SARNIA, ONTARIO

Dustless blasting decontaminates units faster without scaffolding or hoarding

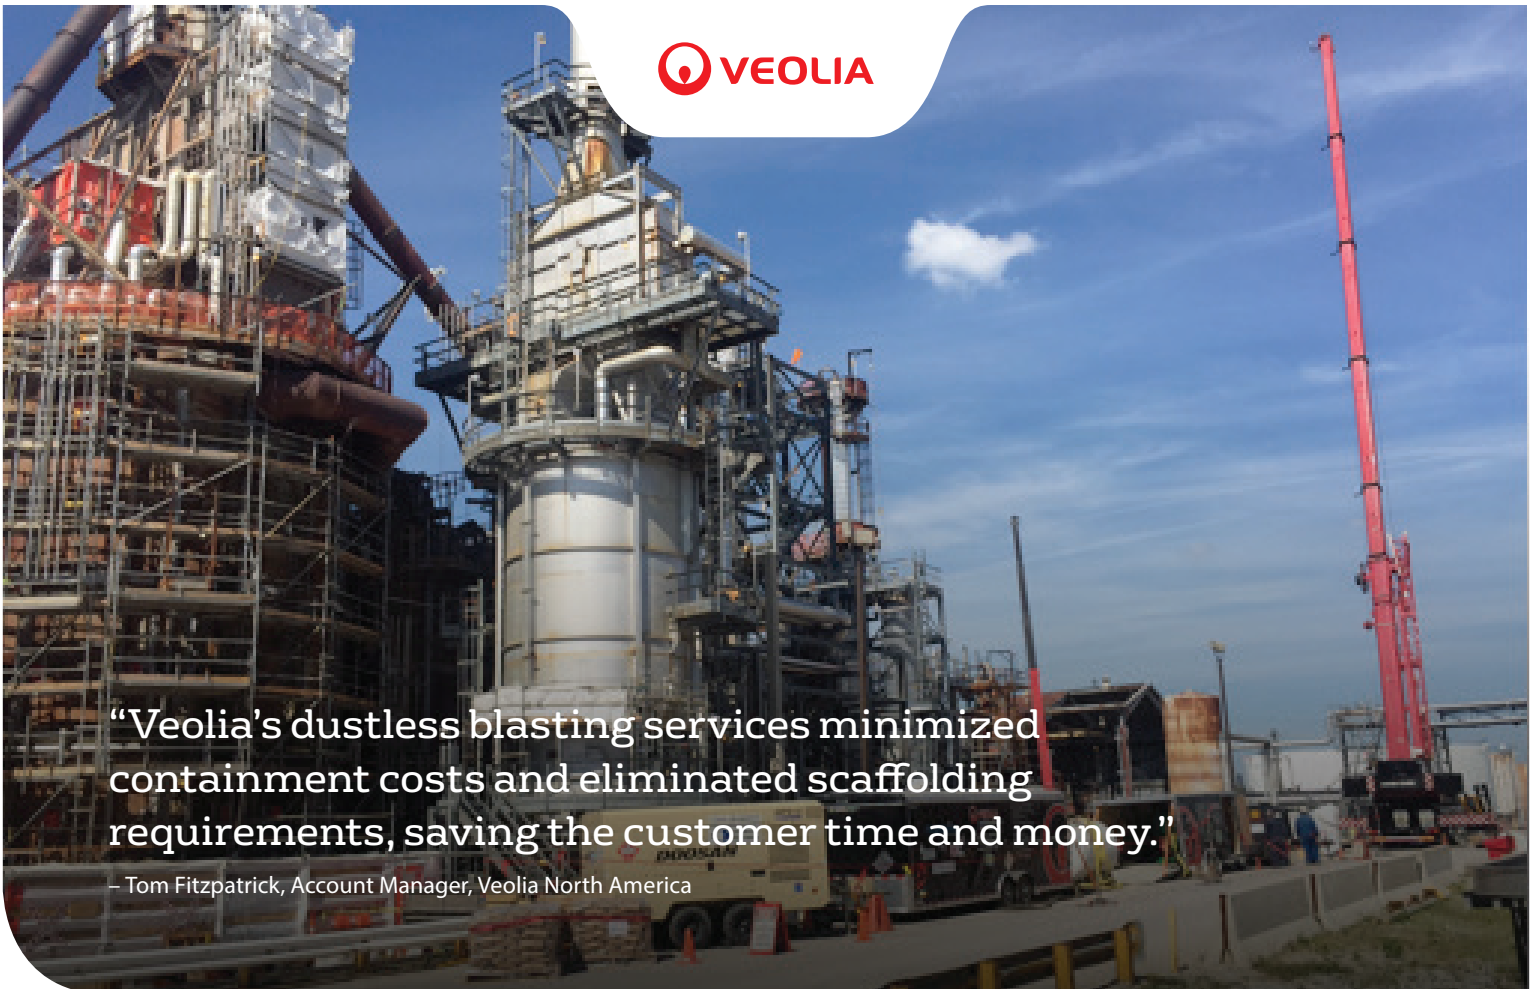
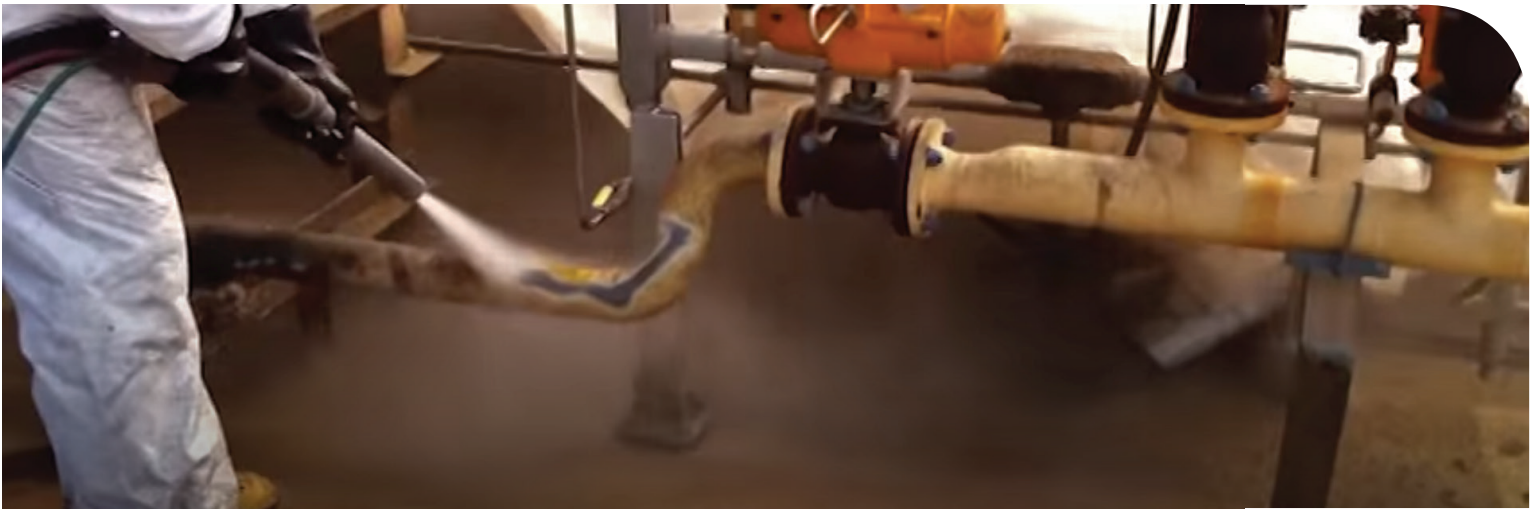
Veolia used their dustless blasting method from the ground and an aerial platform to attack the lead paint with a mixture of water and finely ground recycled bottle glass. The abrasive was trapped in water and is grounded, eliminating the plume of dust created by sandblasting. The need for the scaffolding and hoarding was eliminated since there was no dust cloud produced while cleaning. The toxic paint and wastewater was contained in a berm located at the base of the tank. Veolia was then able to vacuum the residuals and properly dispose of the hazardous waste.

lowered abrasive consumption compared to traditional blasting. Additionally, Veolia sprayed on a rust inhibitor that lasted 72 hours. The chemical decontaminated the tank's blasted surfaces, leaving them clean, chloride-free and ready to paint.

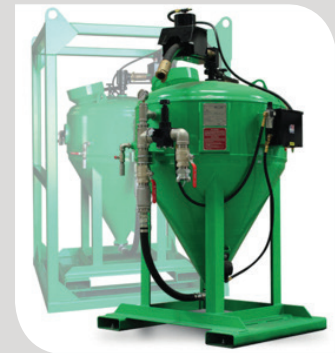
The dustless blasting technology uses water and finely ground glass
