# **Mill Mountain Park Management Plan**

*Adopted as part of the Roanoke Comprehensive Plan by*  
**The Council of the City of Roanoke, Virginia**  
*and by*  
**The Roanoke Planning Commission**

*As Submitted by*  
**The Mill Mountain Advisory Committee**  
**Roanoke Parks and Recreation**  
**and The Department of Landscape Architecture**  
**Virginia Polytechnic Institute & State University**

**February 21, 2006**

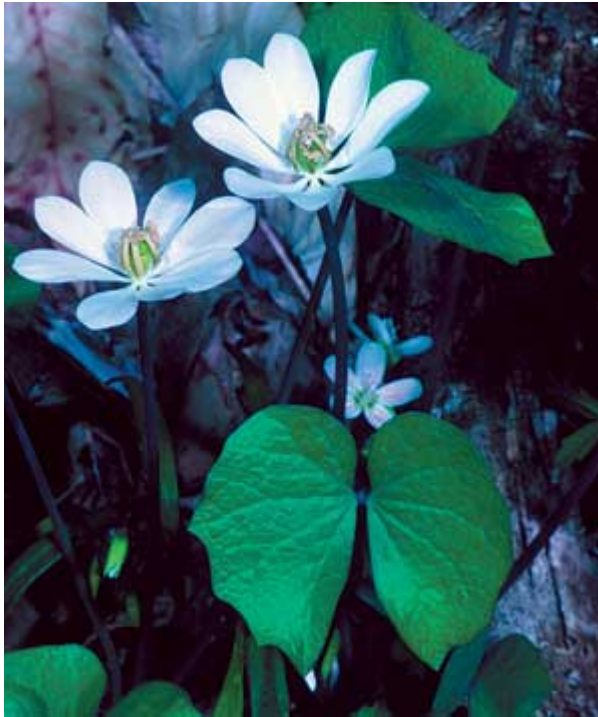
Figure 31. Twinleaf (*Jeffersonia diphylla*). Photo courtesy of the National Park Service. <http://www.nps.gov/plants/pubs/chesapeake/plant/1995.htm>

Within the ornamental landscape of the summit park, one rare species was found. The Wildflower Garden currently contains at least two small patches of *Jeffersonia diphylla* (twinleaf) between the Discovery Center and the garden's pond. Named for Thomas Jefferson, this 8- to 10-inch-tall native plant has deeply divided leaves and produces white flowers in

April–May (Figure 31). It prefers rich, shaded slopes with limestone soil. Although its occurrence is considered rare, the U.S. Fish & Wildlife Service does not list this as a threatened or endangered plant.

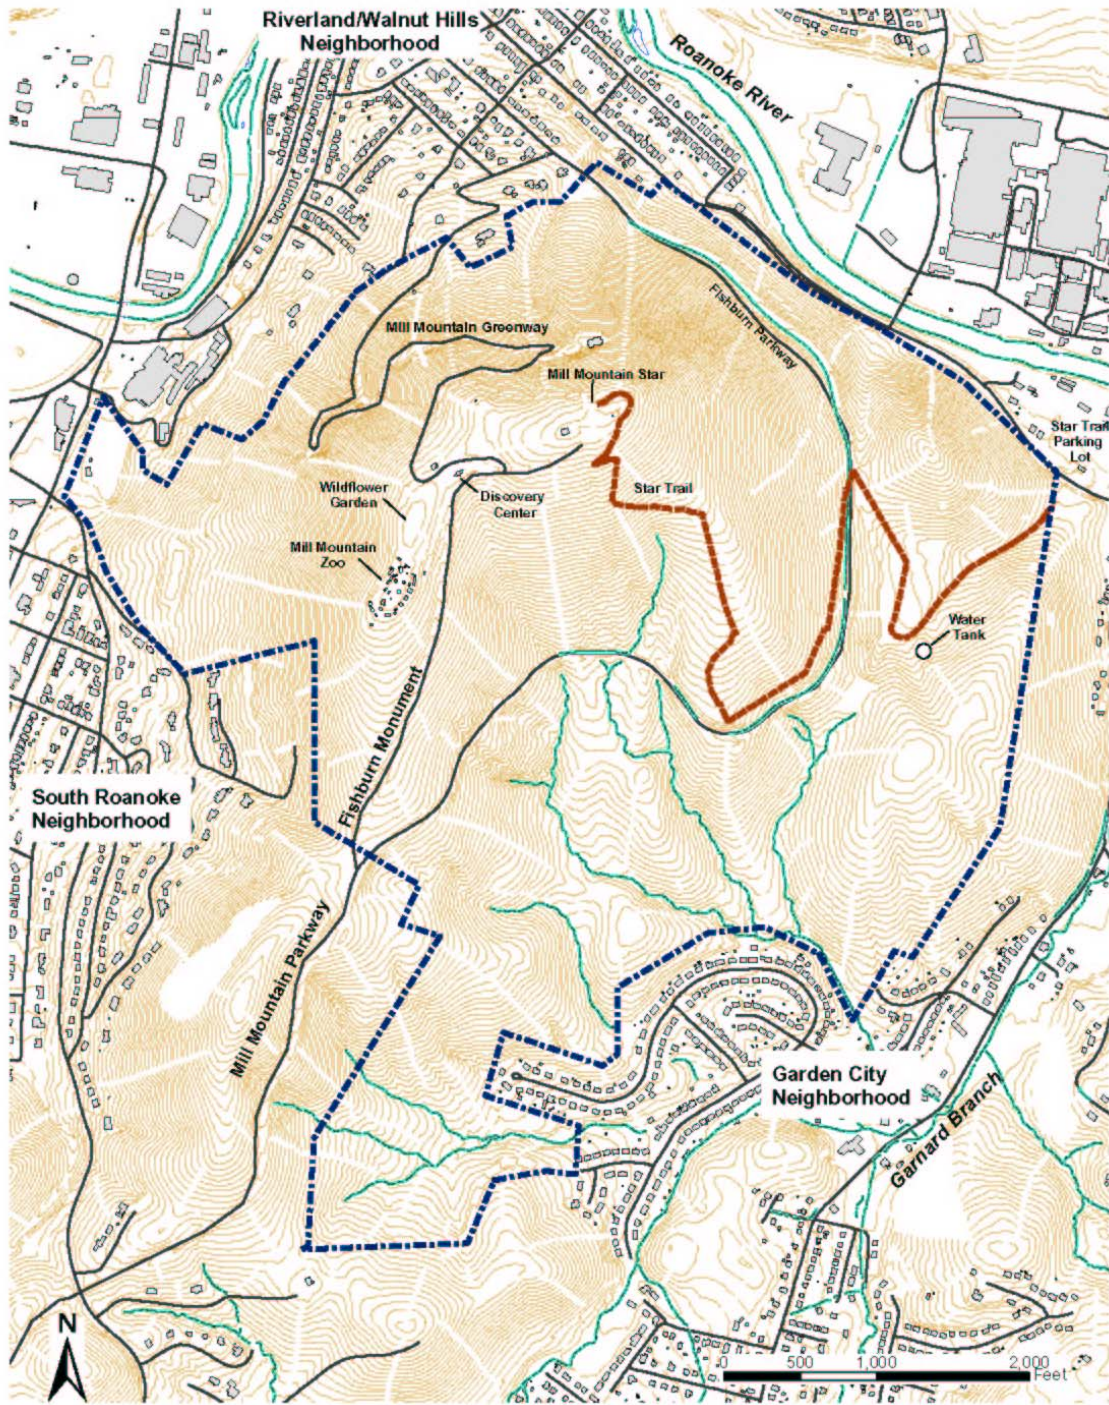
Figure 2. U.S.G.S. topographic quadrangle

Figure 3. Existing conditions

Figure 4. Aerial photograph

This management plan covers the entire park, consisting of approximately 568 acres. Figure 1 identifies the location of Mill Mountain Park in the City of Roanoke. Figures 2, 3, and 4 depict existing conditions in the park (base maps), and Figure 5 shows in detail the mountain top where park development is concentrated.

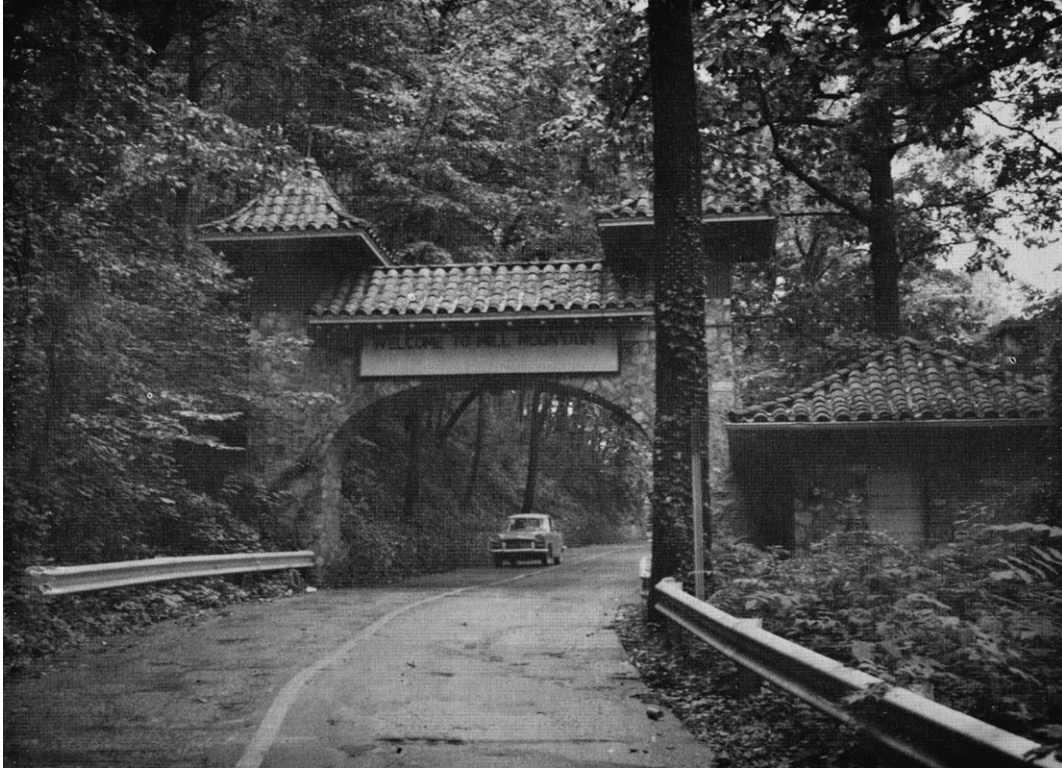
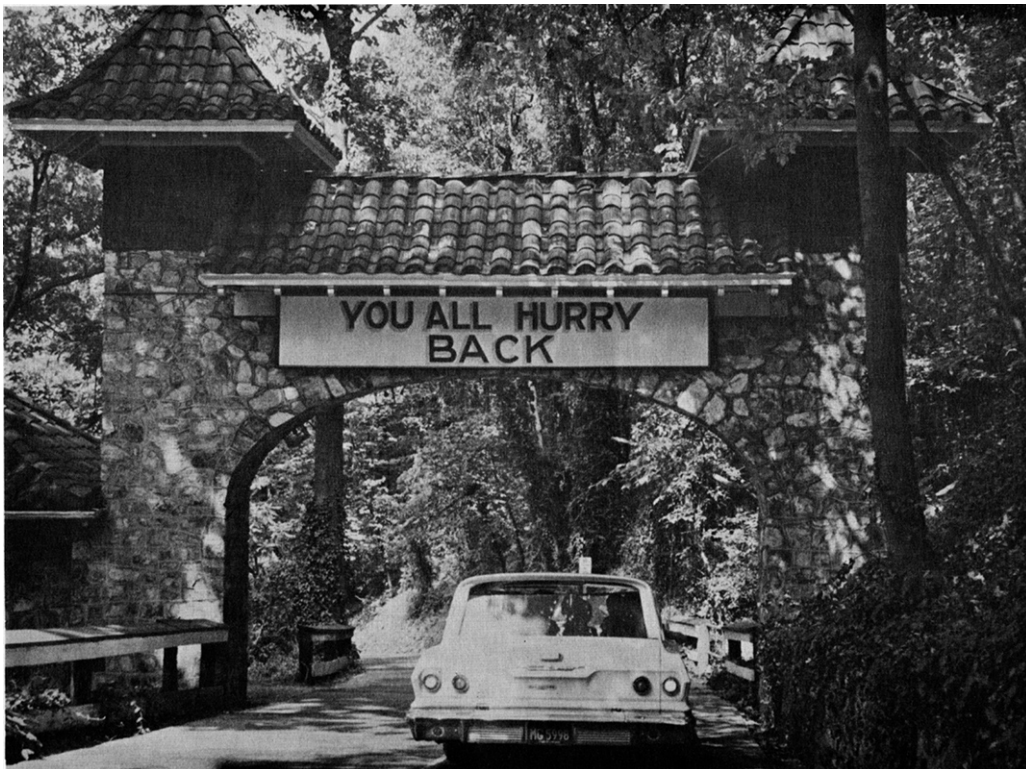
Figure 32. Toll road entrance

Figure 33. Toll road exit

- *Toll House.* This structure, located at the entrance to the toll road, includes a stone archway over the road with an attached toll house. Although the road opened before construction was completed on the toll house, it should be considered an original feature of the 1924 road. In general, the structure appears to be in good condition, although a crack is visible in the toll house's uphill-facing wall. In addition, the wood shingle roof requires some repairs, and the wood cornice over the archway has suffered some rot. Photographs from the 1960s indicate that at least at that time, the structure had a tile roof (see Figures 32 and 33). More research is needed to determine if this roof was the original.
