MAKE DATA MATTER.

SIXTH EDITION

2020 PV Module Reliability Scorecard

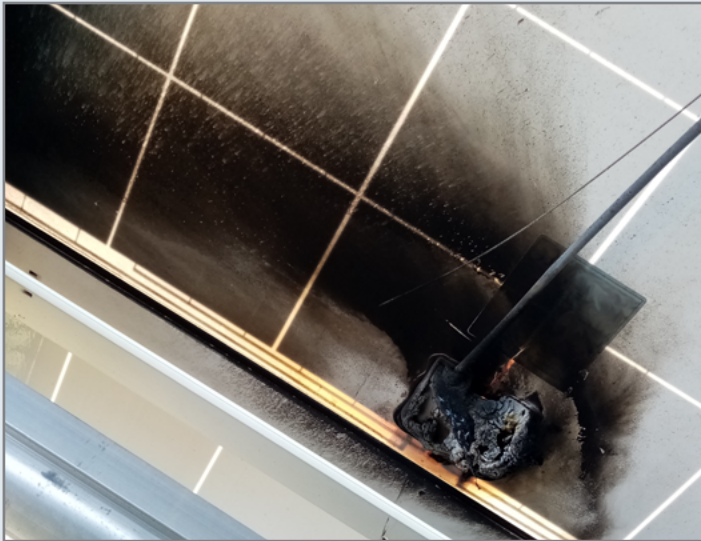
The image above shows a PV module at the project site with a junction box that melted due to electrical arcing.

A 50 MW PV plant in Africa built in 2013 began to exhibit serious failures from poor soldering and failed diodes after just five years of operation.

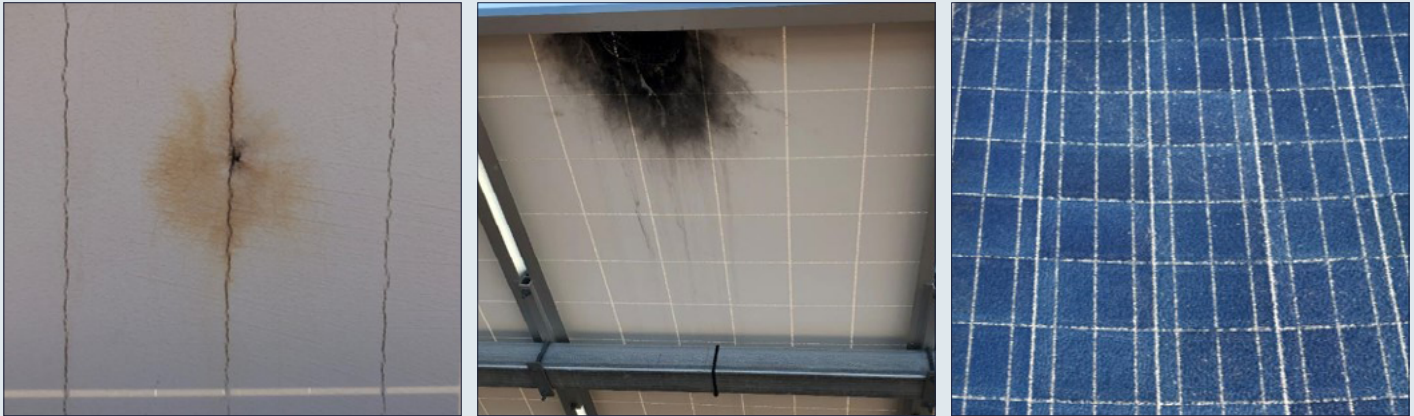
The pictures above are from a 17 MW project in the Southwest U.S. One hundred percent of the backsheets in this project are cracked. The severe scorching in the backsheet above was caused by electrical arcing at the backsheet cracks that intercept the frame. The thermal event shattered the front-side glass.

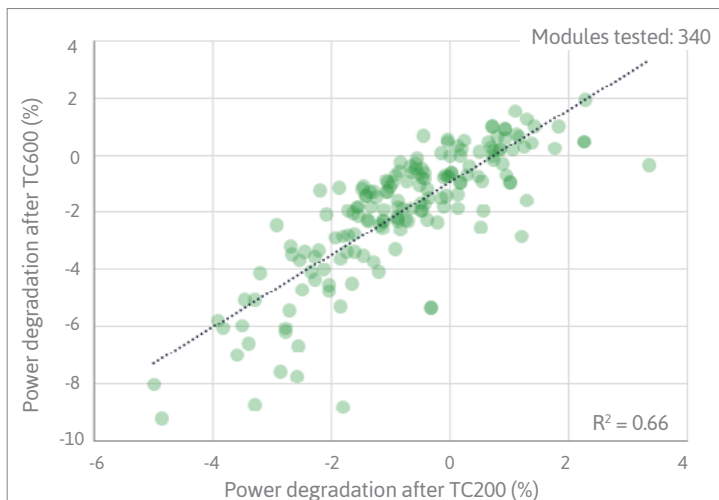
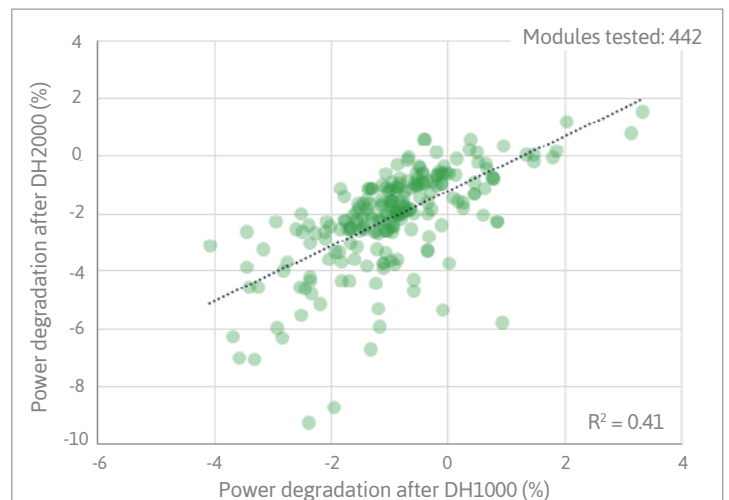
Scatterplots showing correlations between various stages of the TC and DH tests

For the thermal cycling test, the correlation between 200 cycles and 600 cycles indicates no new mechanisms are being introduced by the 600 cycle test, yet stopping at 200 cycles might be premature (see figure below left). Reviewing the historical 600 cycle and 800 cycle correlation indicates that TC600 is a sufficient test duration. The damp heat correlation between 1000 hours and 2000 hours suggests 1000 hours is not an adequate substitute for 2000 hours (see figure below right), while the historical correlation between 2000 and 3000 hours indicates that less relevant failure mechanisms may be introduced. The data shows that 2000 hours is optimal.
