Washington State
School Seismic Safety Assessments Project

MARY M. KNIGHT SCHOOL ELEMENTARY SCHOOL BUILDING Mary M. Knight School District 311

SEISMIC UPGRADES CONCEPT DESIGN REPORT

June 2021

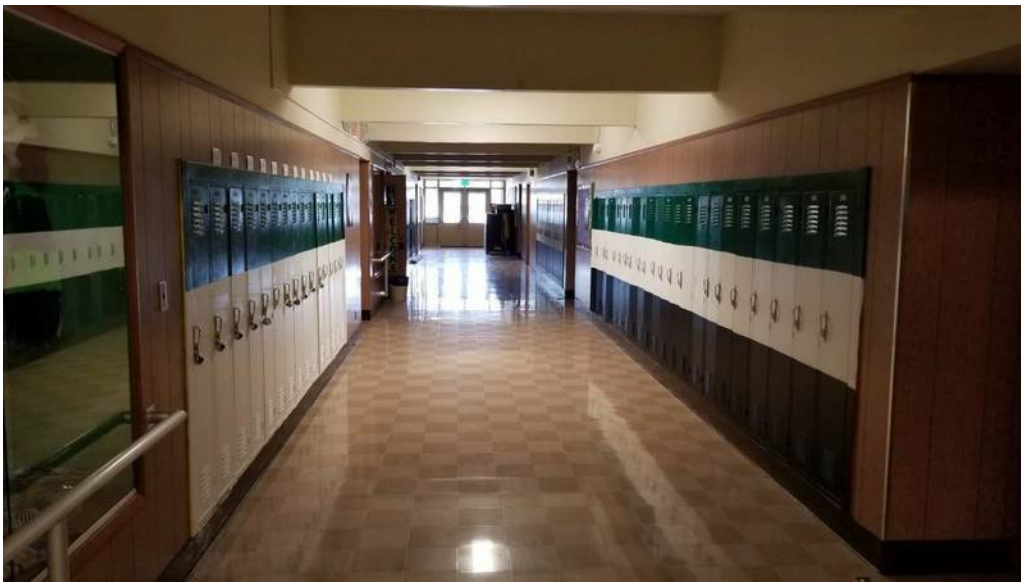
Figure 1-2. Typical hallway with lockers.

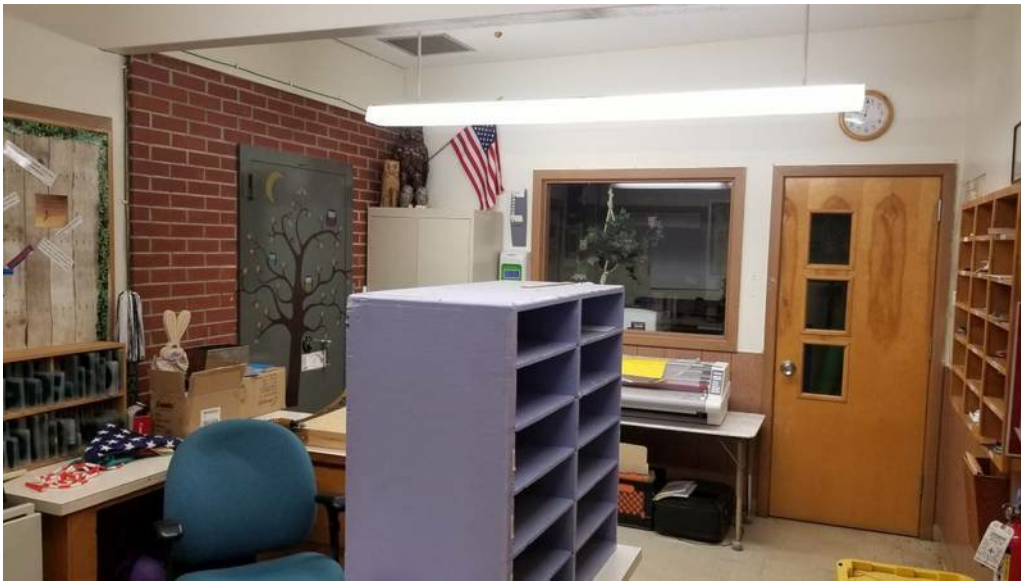
Figure 1-3. View in administrative area.

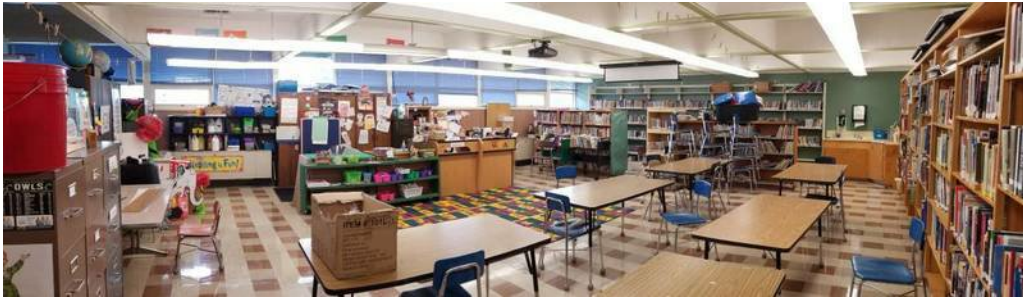
Figure 1-6. View of Library.
