Hope Island Atlantic Salmon Net Pens Engineering Assessment

January 29, 2018

State of Washington
Department of Natural
Resources
1111 Washington Street SE
Olympia Washington 98504

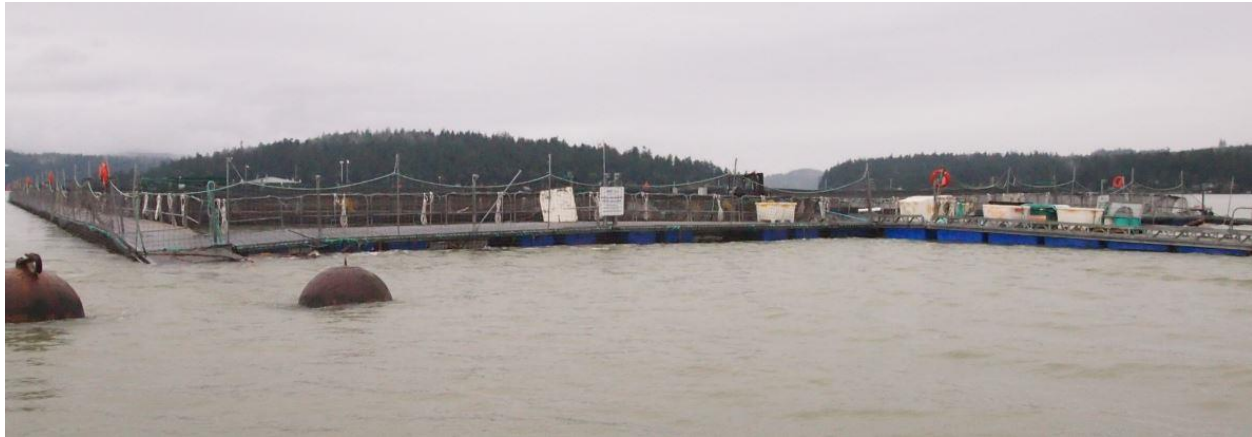
Figure 9: Hope Island Net Pens – View from South

During the site visit observations were made and photos were taken. On November 27 at noon the weather was cool, 50°F, overcast sky, with winds light and variable, the sea calm. There was a constant current flowing from the south observed to be approximately 0.75 knots near the net pen structure and an estimated 1.5 knots further out from the net pen at 11:35 am on November 27, 2017. This current caused no observable motion to the net pen. The predicted tide elevations are below in **Table 3**. Mean Higher High Water (MHHW) is elevation +11.05 feet, MLLW. Mean Lower Low Water is +0.00, MLLW. The mean tide range was 7.63 feet. The predicted currents are in **Table 4**. The maximum predicted surface current speed during the site visit was approximately 1.9 knots during the peak flood.

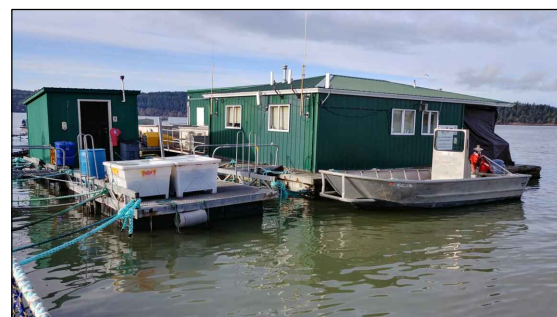
PHOTO 1
FLOATING BARGES

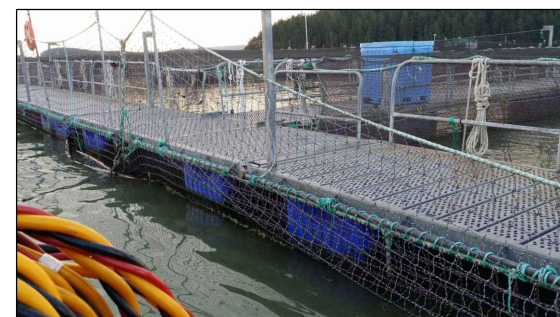
PHOTO 2
EXTERIOR WALKWAY AND PREDATOR NET

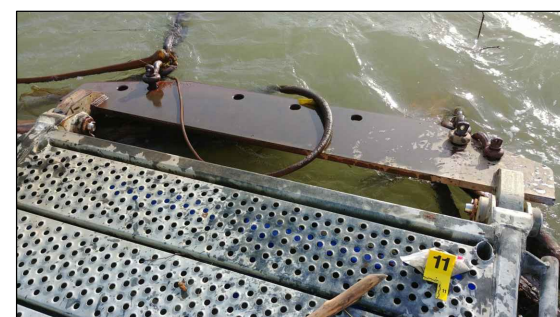
PHOTO 7
HINGED MOORING BRACKET AND ANCHOR CHAINS

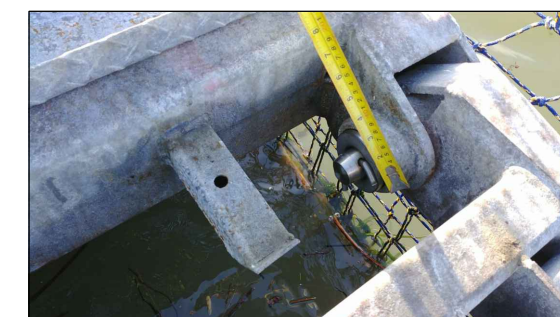
PHOTO 10
WALKWAY HINGE

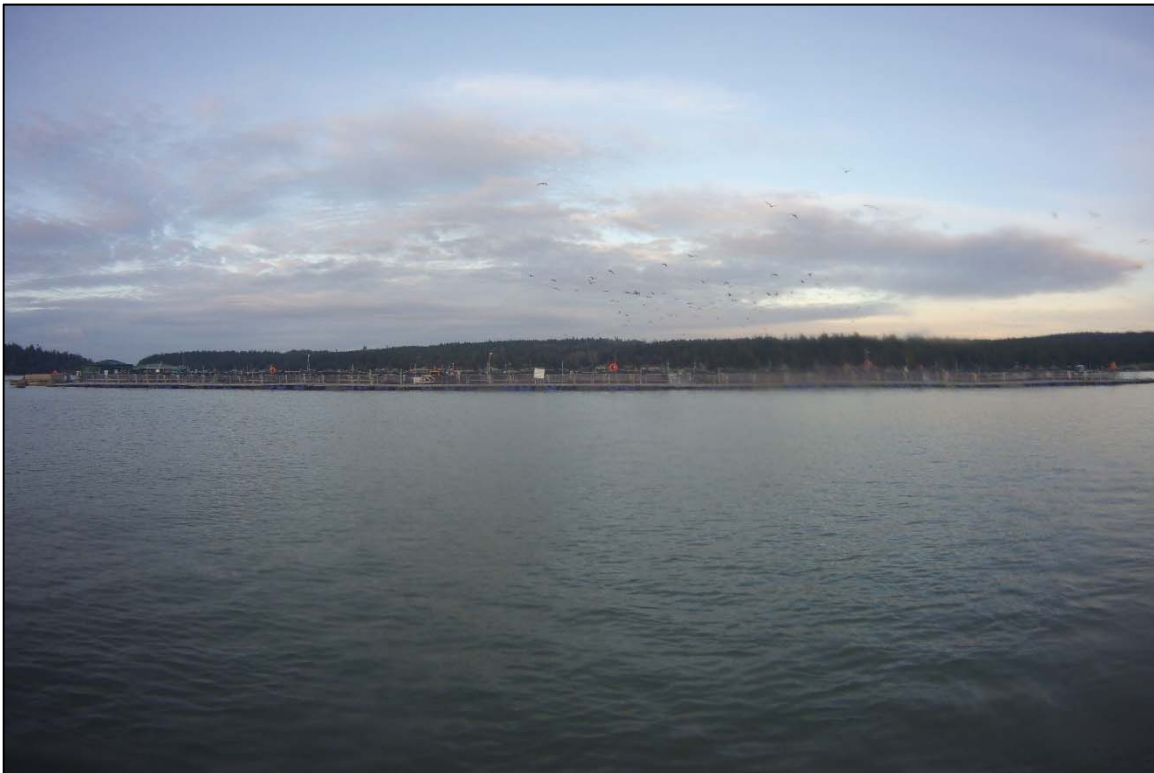
Photograph 2: Overall View of the Fish Net Pen System, Looking East.

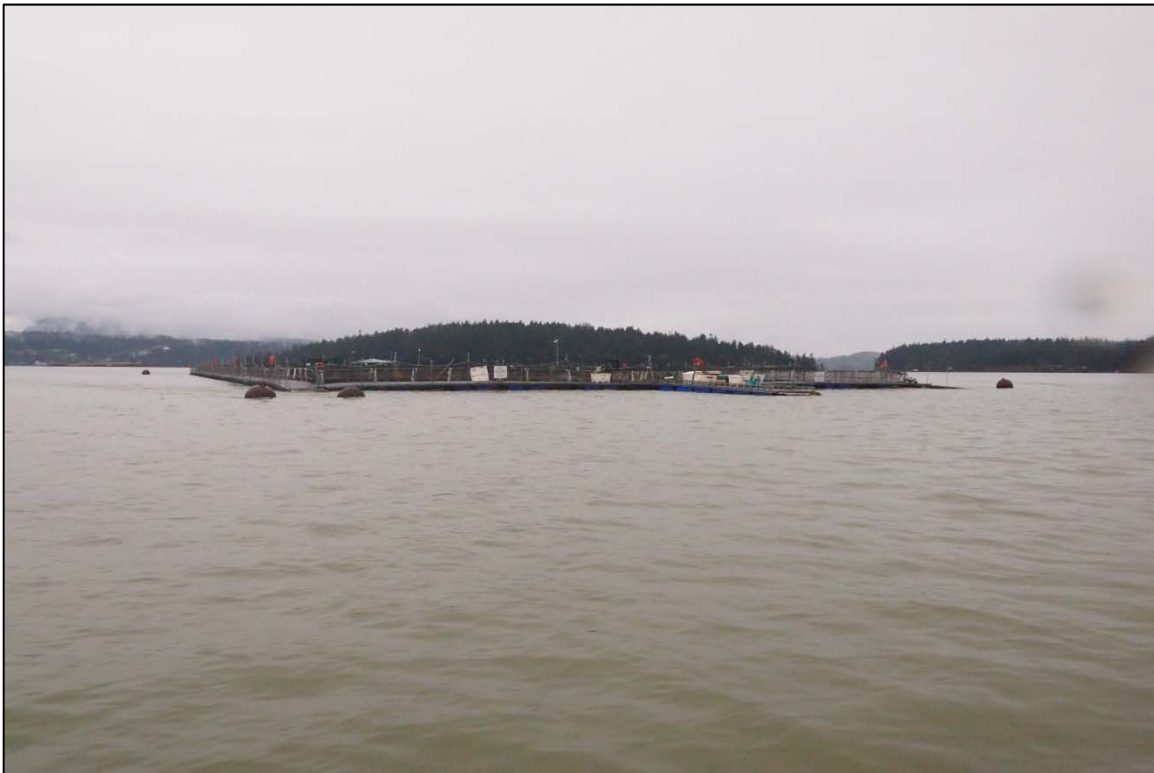
Photograph 6: Overall View of the Fish Net Pen System, Looking Northeast.

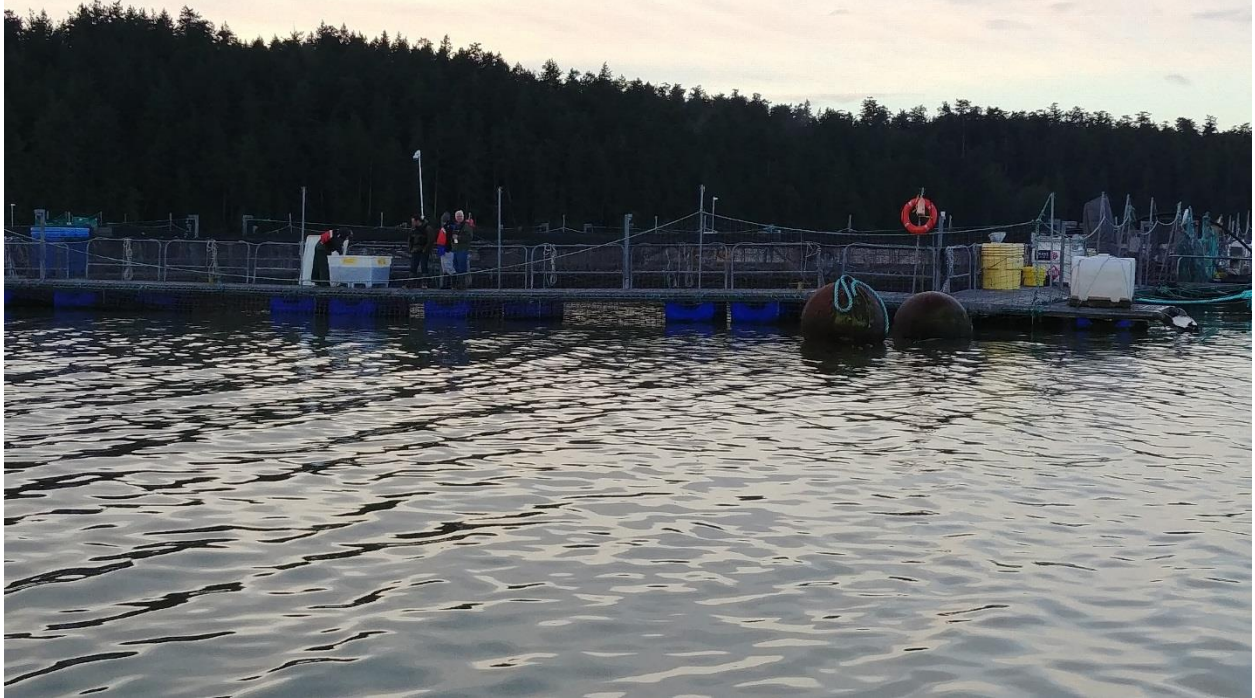
Figure C-4: Hope Island Net Pens - NE Corner of Pens

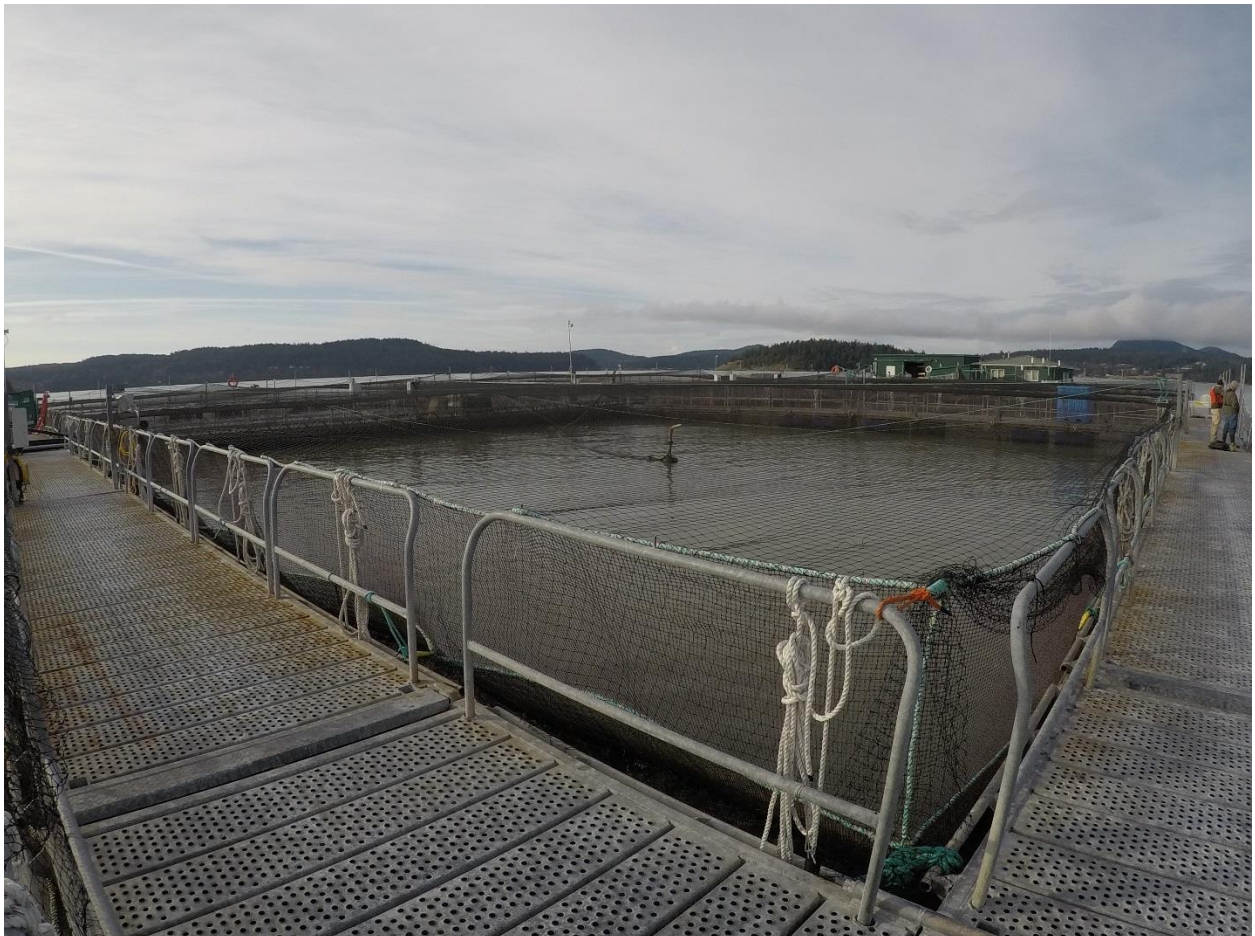
Figure C-5: Hope Island Net Pens - SE Corner of Pens, Looking North

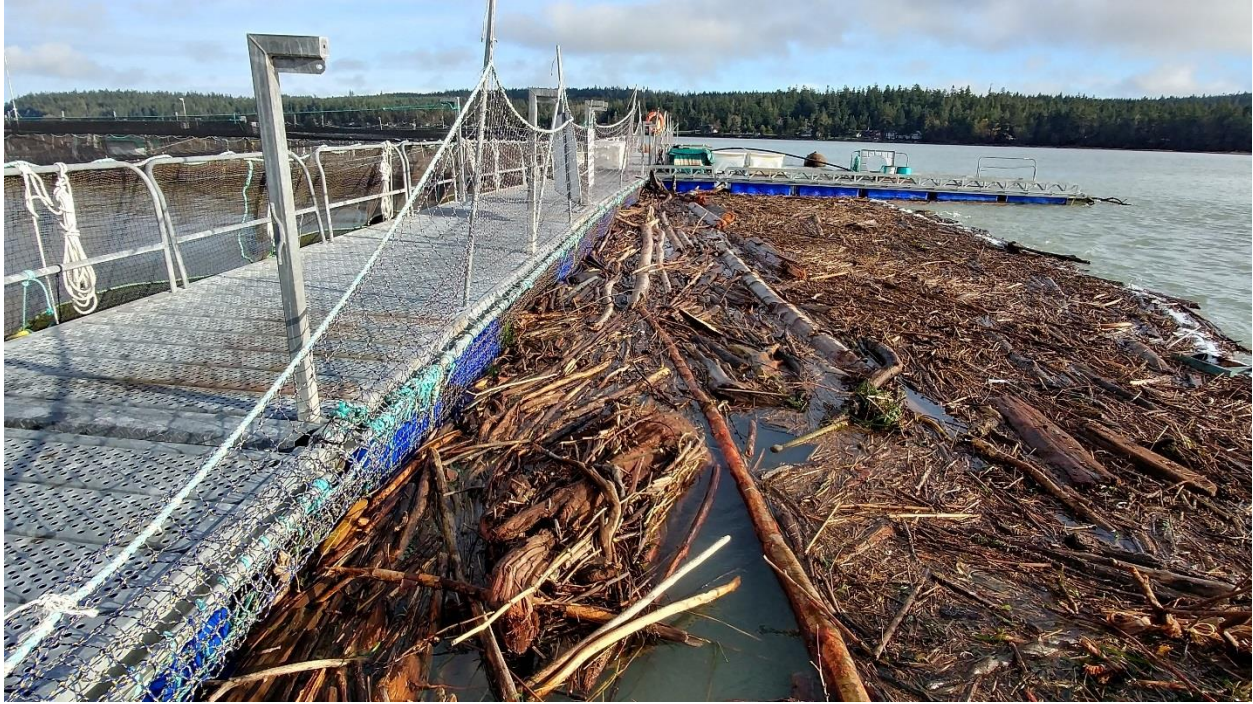
Figure C-14: Hope Island Net Pens - Debris Buildup on South End, Looking East

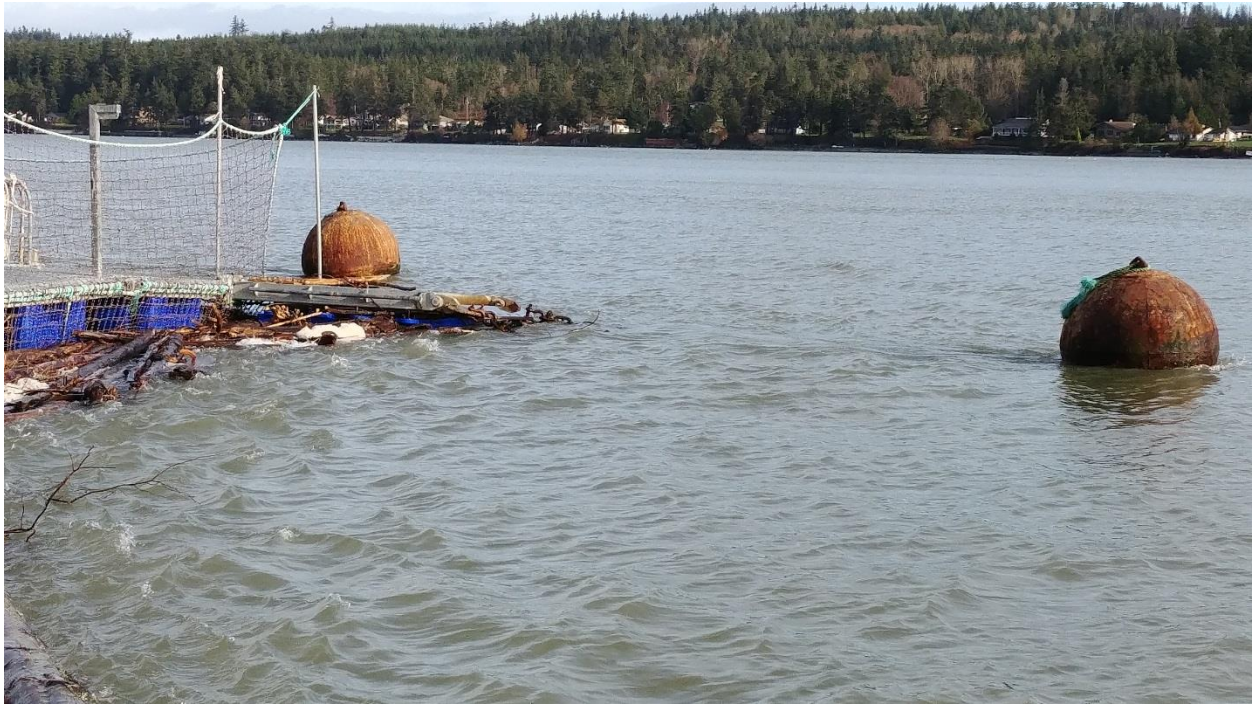
Figure C-16: Current from the South Traps Debris Against the Net Pen

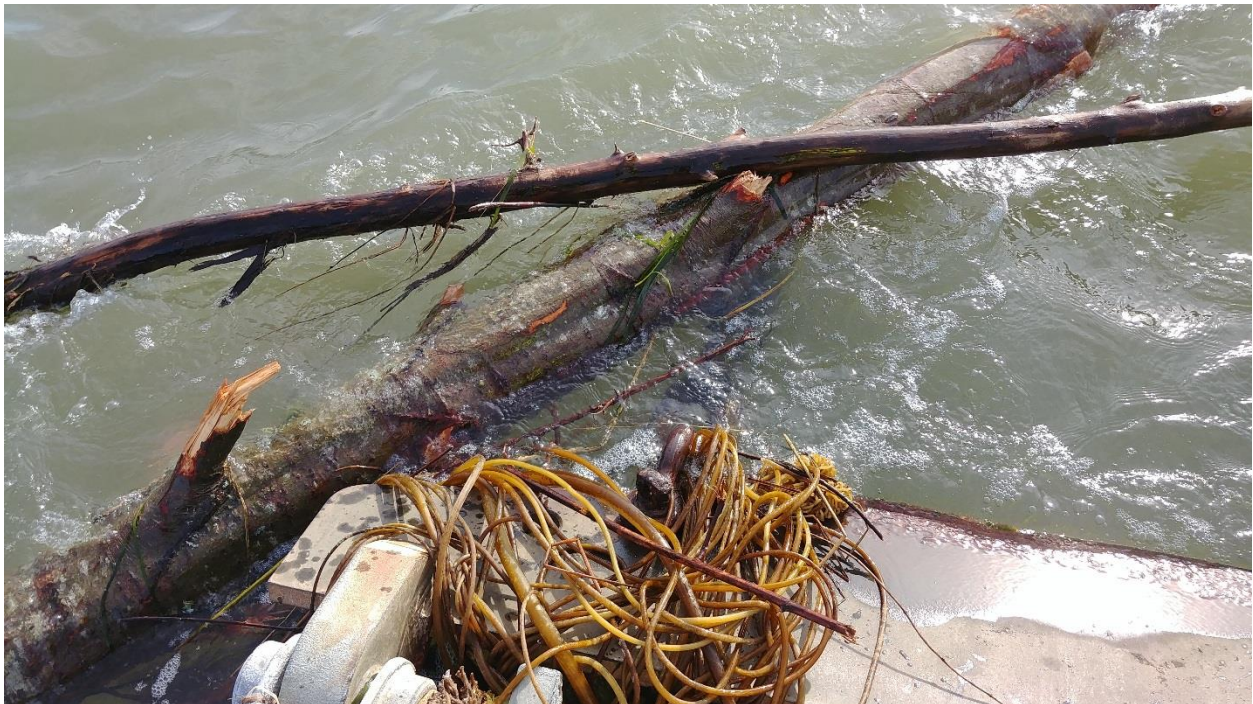
Figure C-17: Current from the South Traps Debris Against the Net Pen

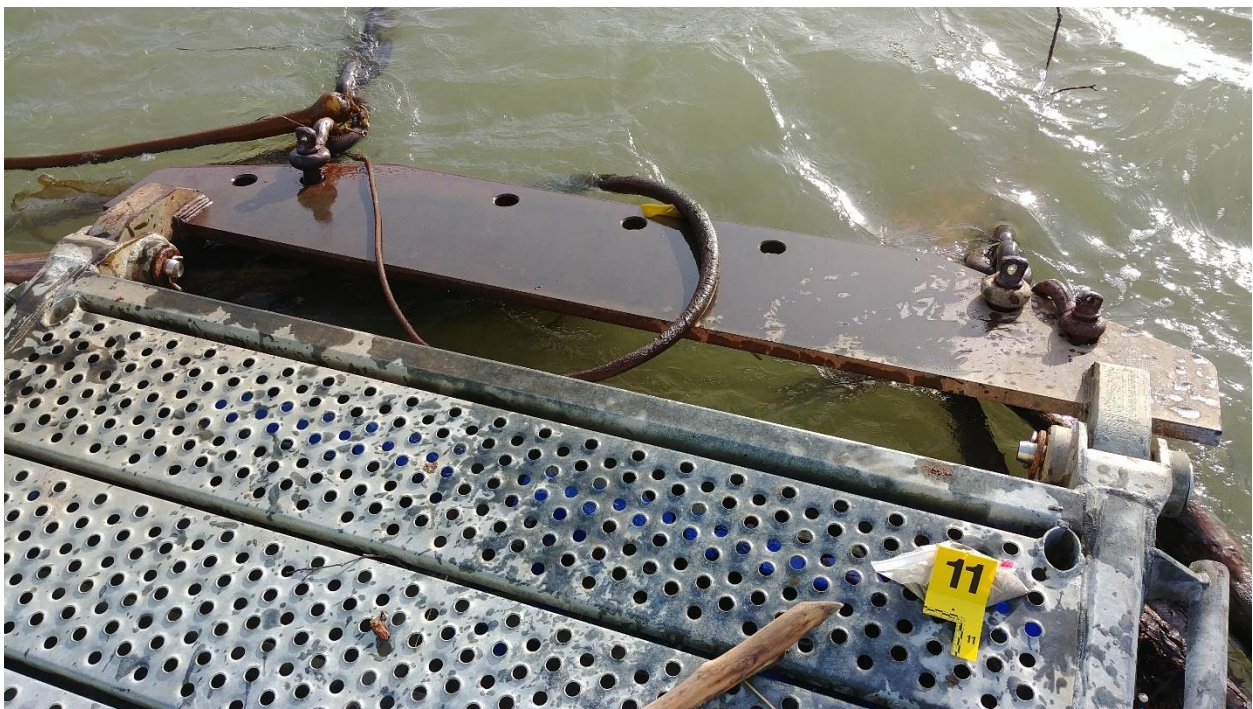
Figure C-40: Anchor #11, SE Corner of the Net Pens

- The anchor line rope at Anchor 11 exhibited minor abrasion damage where it passed by and was in contact with a large concrete block located on the seabed.

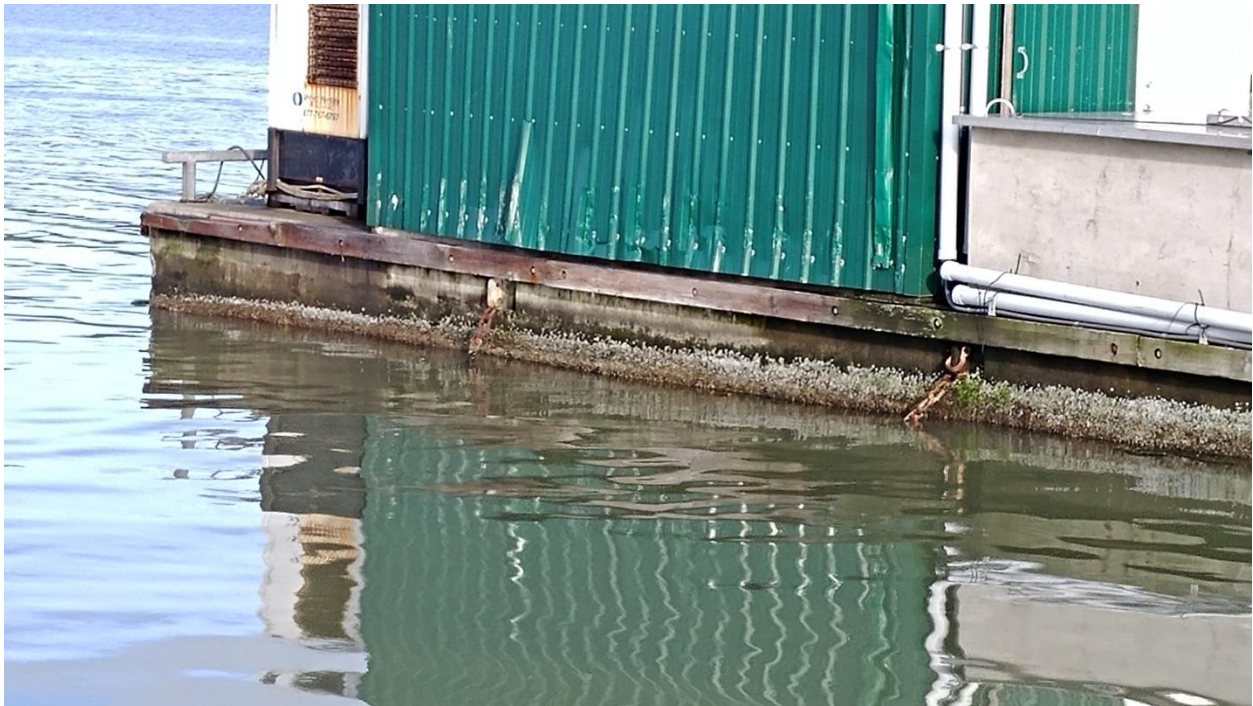
bottom conditions suggested that the anchor was well-seated and gripping adequately in the seabed. As for Anchor Line 25, which is a supplemental anchor line that just stabilizes the barge supporting one of the facility's buildings, it should be noted that there was a very heavy accumulation of apparently abandoned rope around the anchor line rope itself, such that it was deemed to be unfeasible to progress the ROV beyond the rope accumulation, especially given the very limited underwater visibility at the time of inspection.

Figure C-68: Anchor #25, West Side of Feed Barge. Anchor Bridle System.

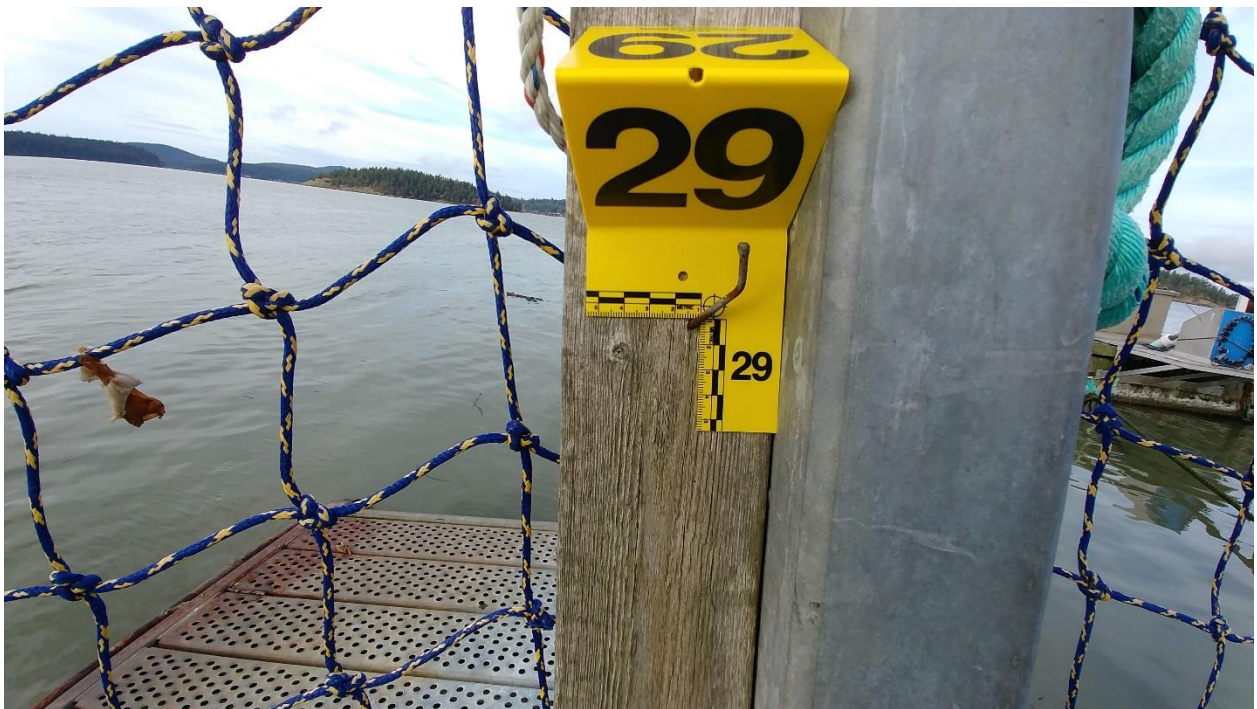
Figure C-72: Dissimilar Metals

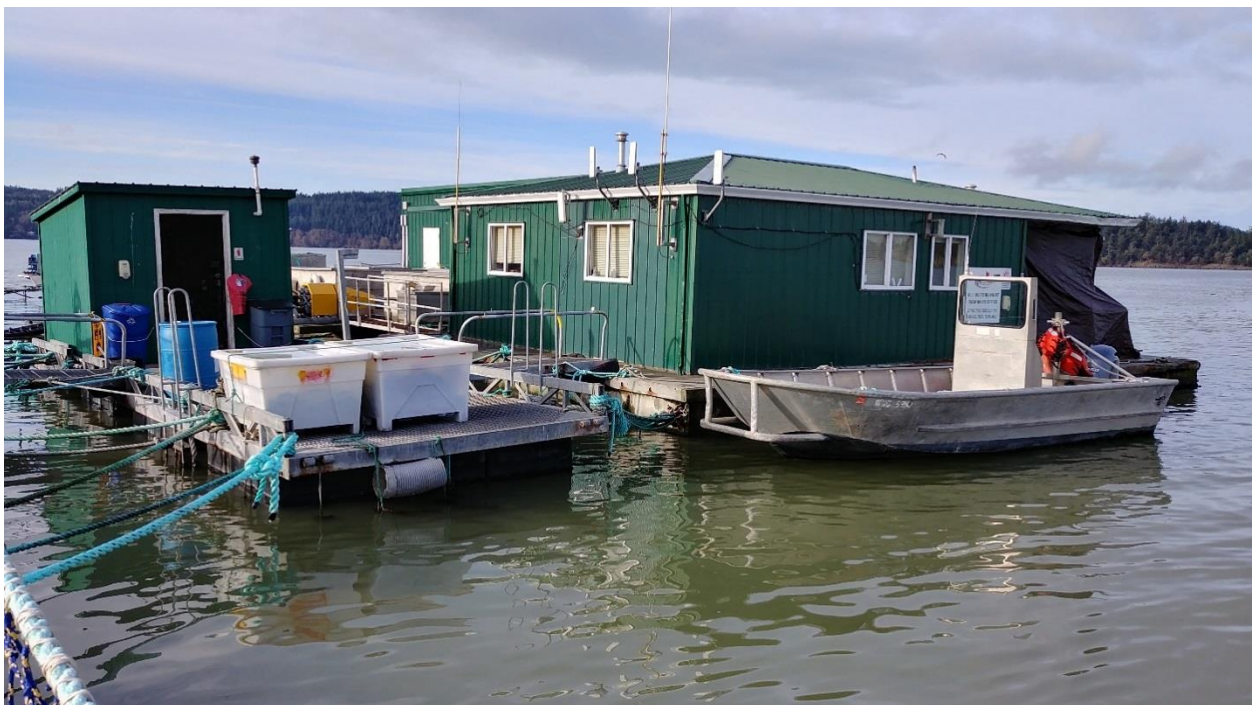
Figure C-82: Concrete on South Side of Feed Barge is Cracked and Nearly Spalling Off

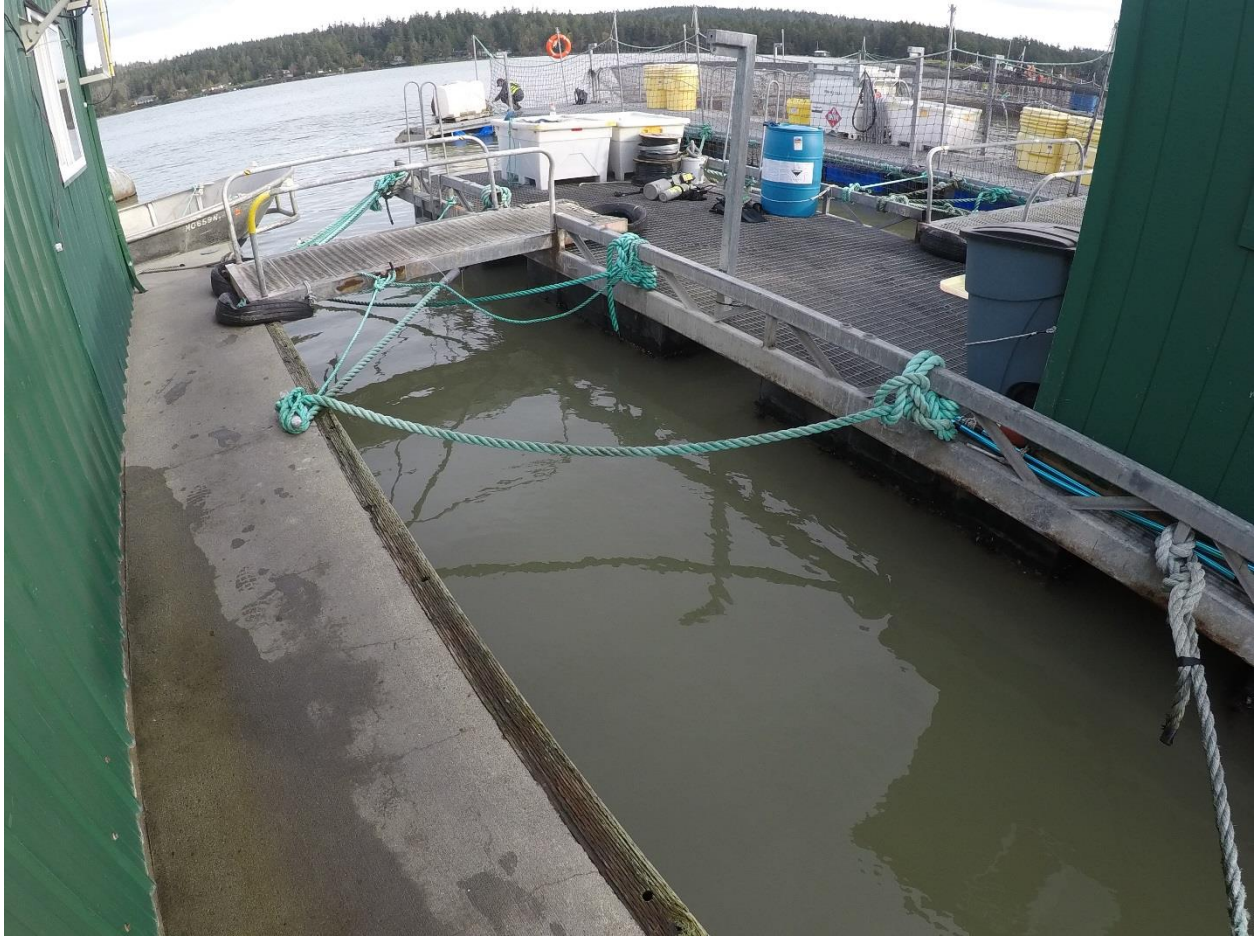
Figure C-85: Gangway Connecting Dive Float to Main Barge. Note No attachment, only Bearing.

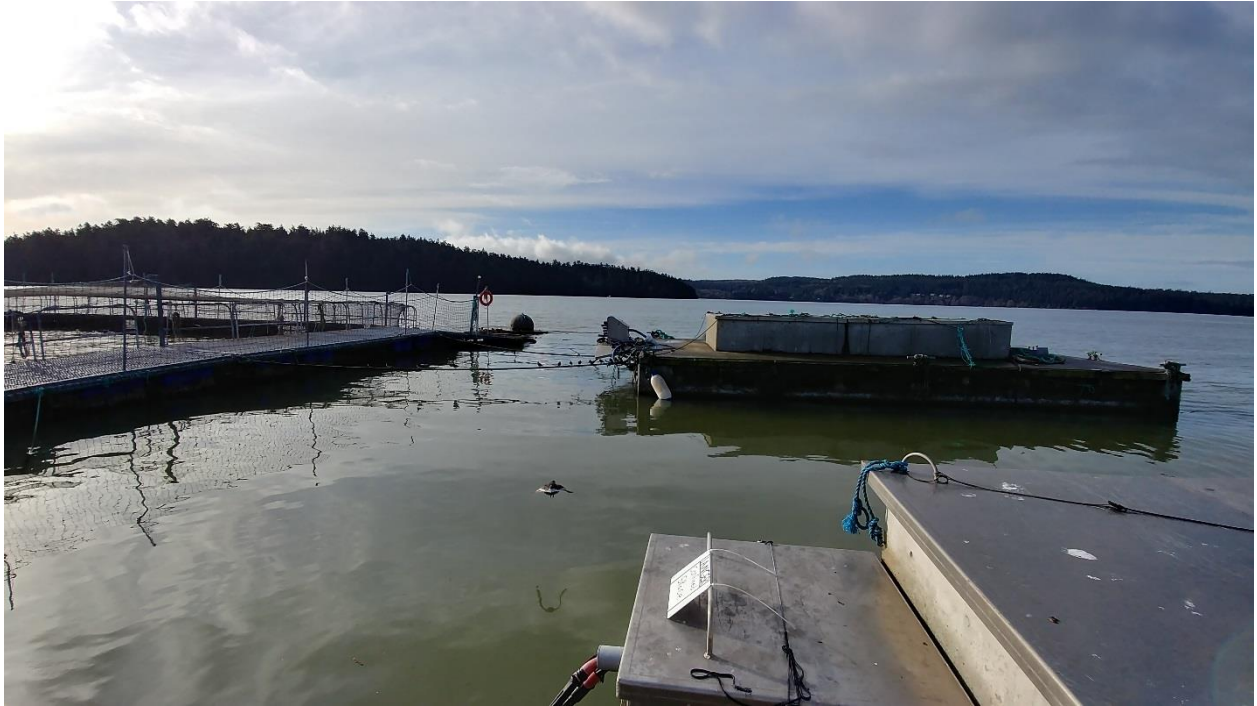
Figure C-91: Metal Siding on West Face of Feed Barge is Not Attached, Peeling Away from Wall

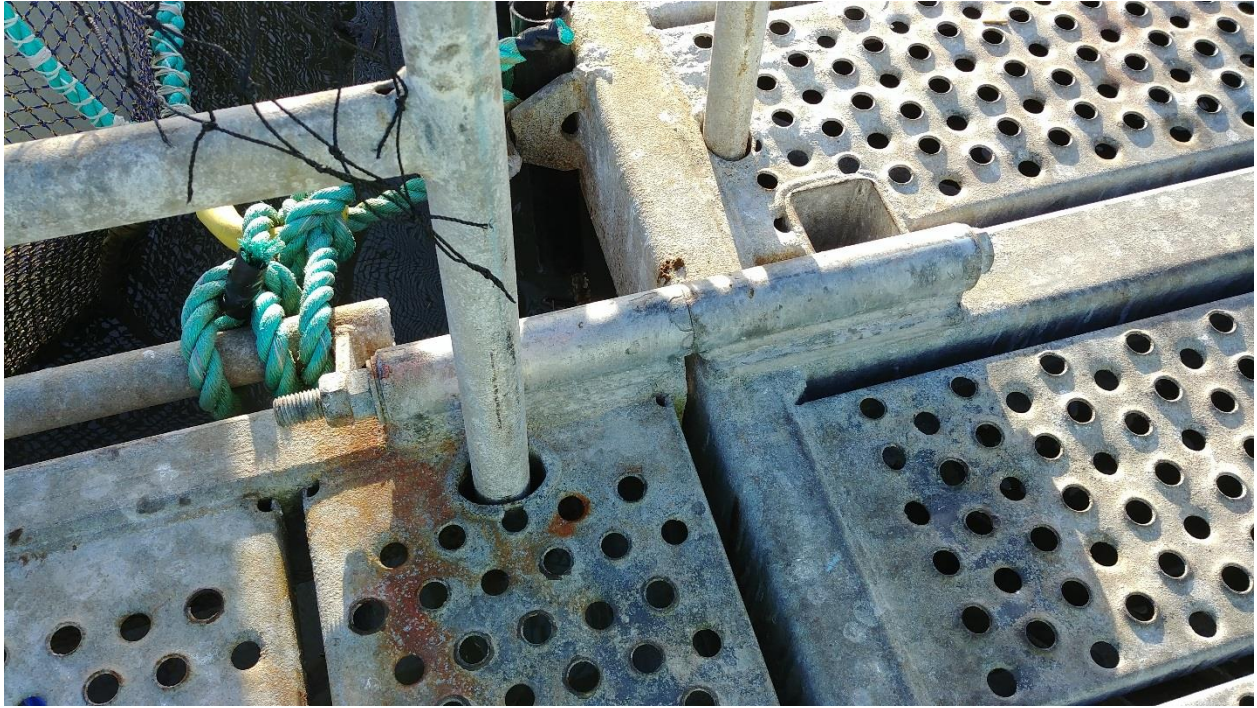
Figure C-93: Additional Feed Barge Tethered to Net Pens.

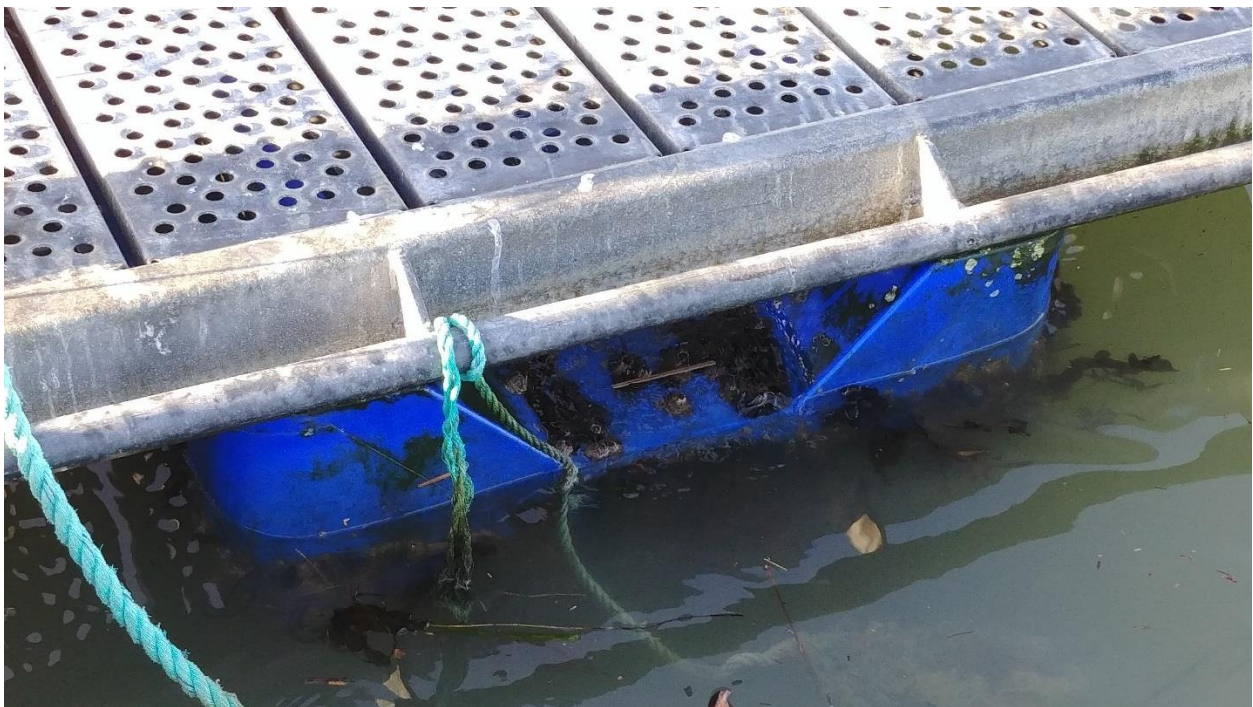
Figure C-100: Walkway Hinge Bushing, Containment Net Railing Being Used as a Conduit

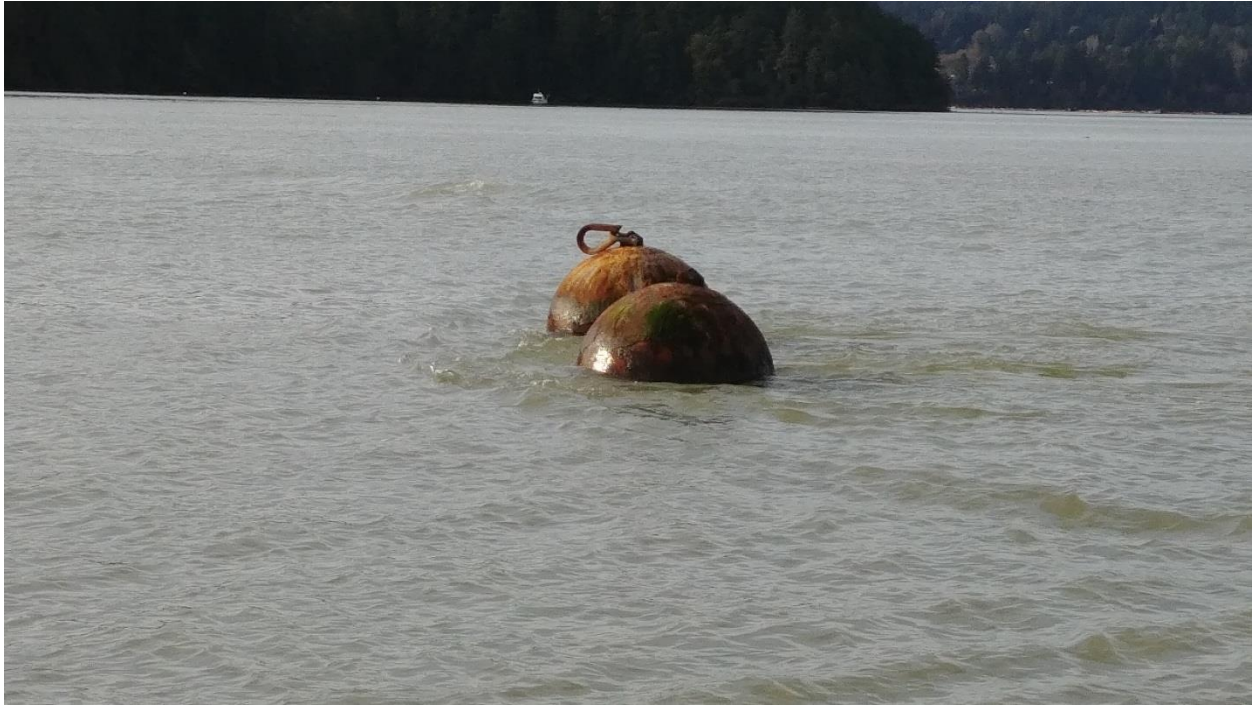
Figure C-103: Mooring Buoys, SE Corner. Note the Current and the Floating Debris.
