# **Cypress Island Site 1 Atlantic Salmon Net Pens Engineering Assessment**

January 29, 2018

**Document reference:** 391980 | 6 | b

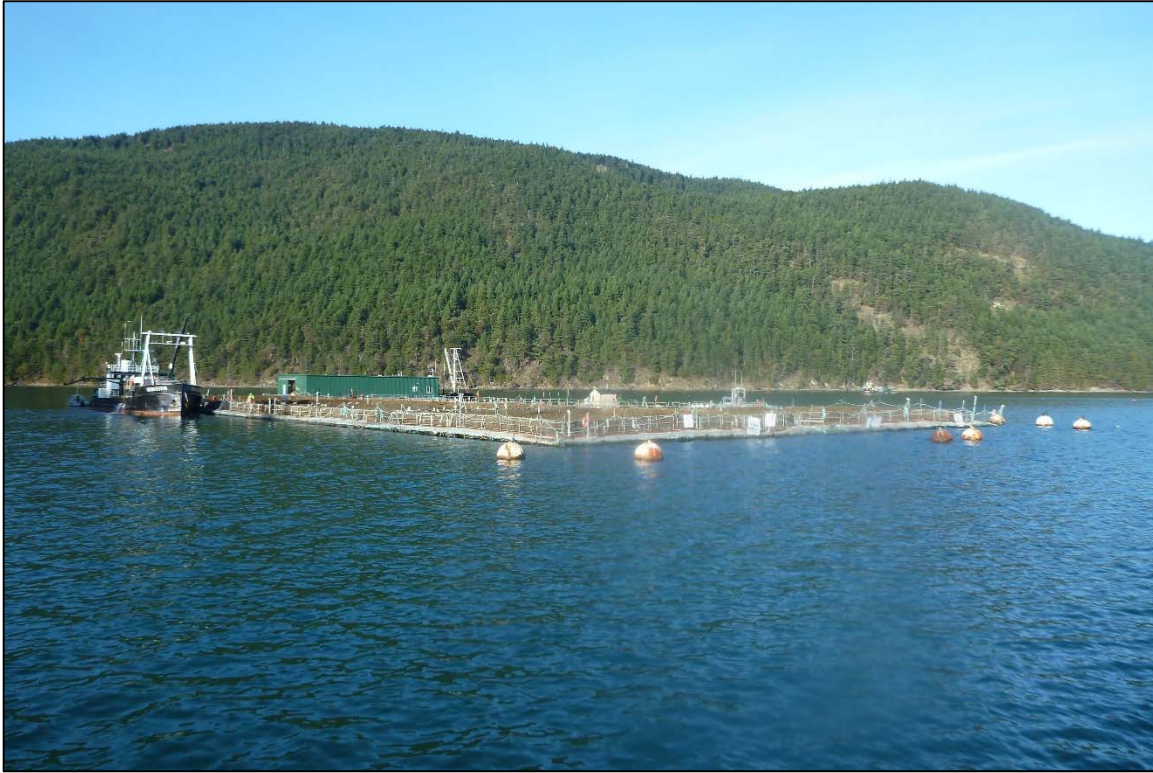
Photograph 1: Overall View of the Site 1 Fish Net Pens System, Looking Northwest.

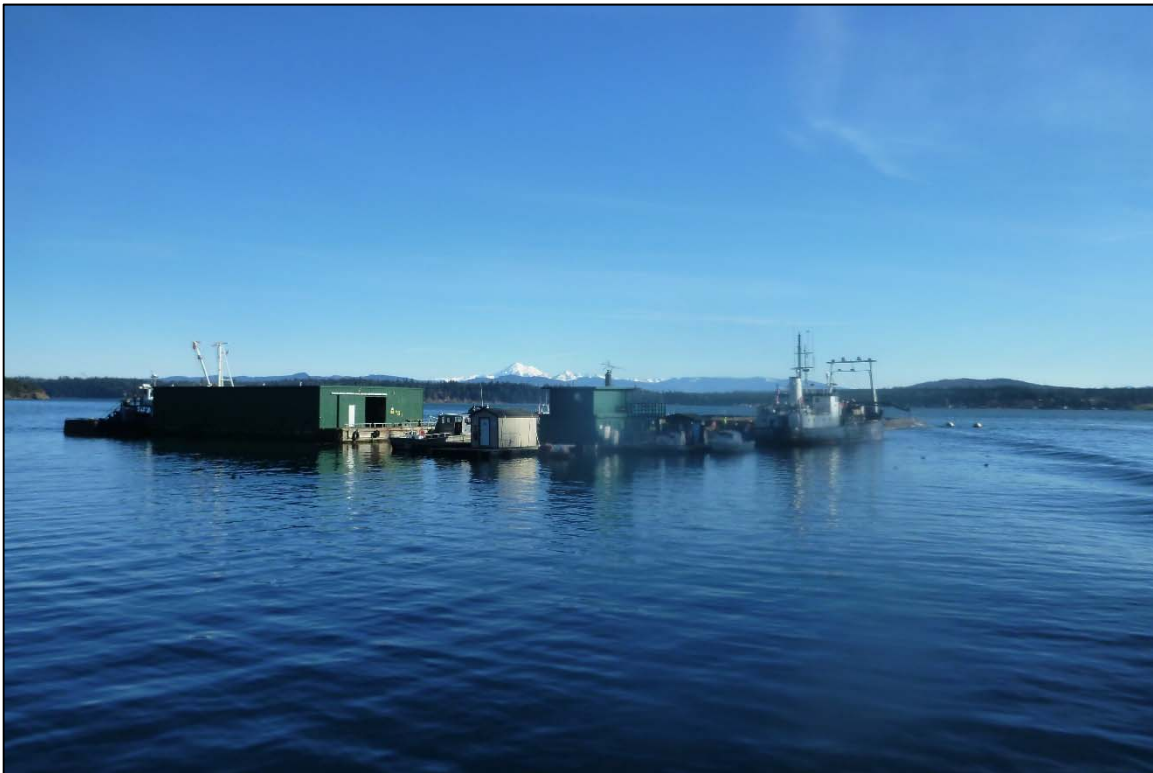
Photograph 2: Overall View of the Site 1 Fish Net Pens System, Looking Northeast.

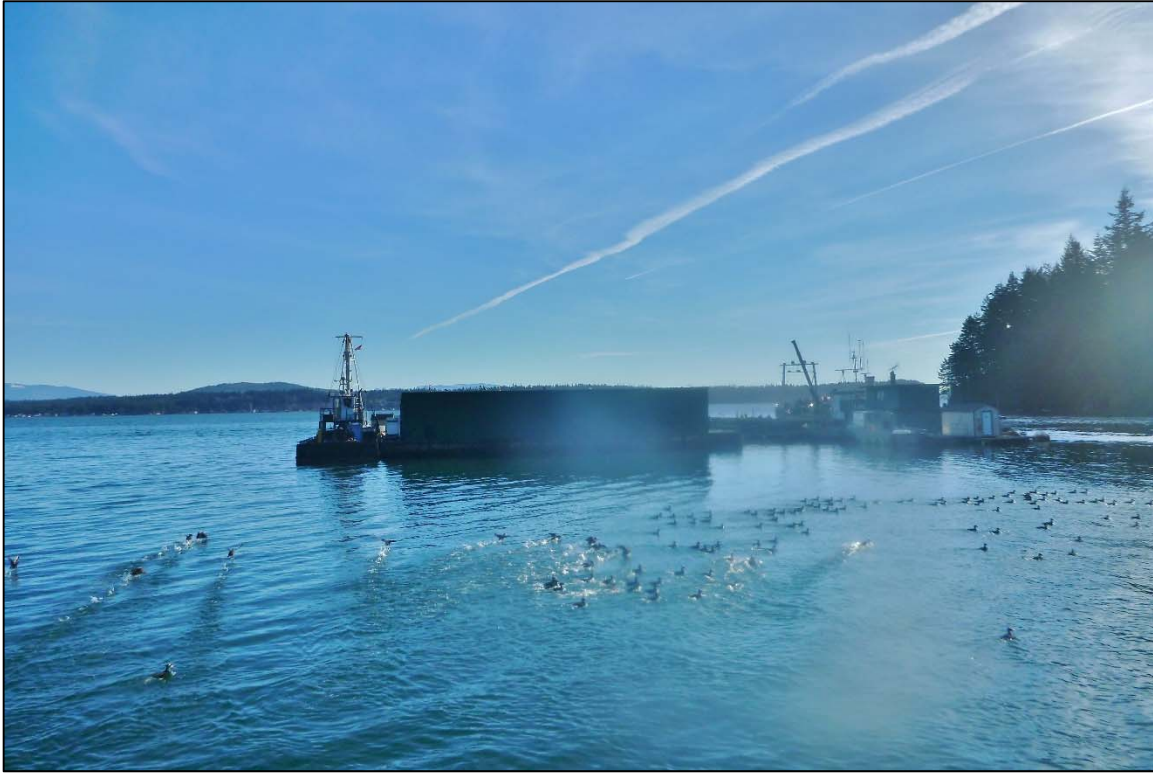
Photograph 3: Overall View of the Site 1 Fish Net Pens System, Looking East.

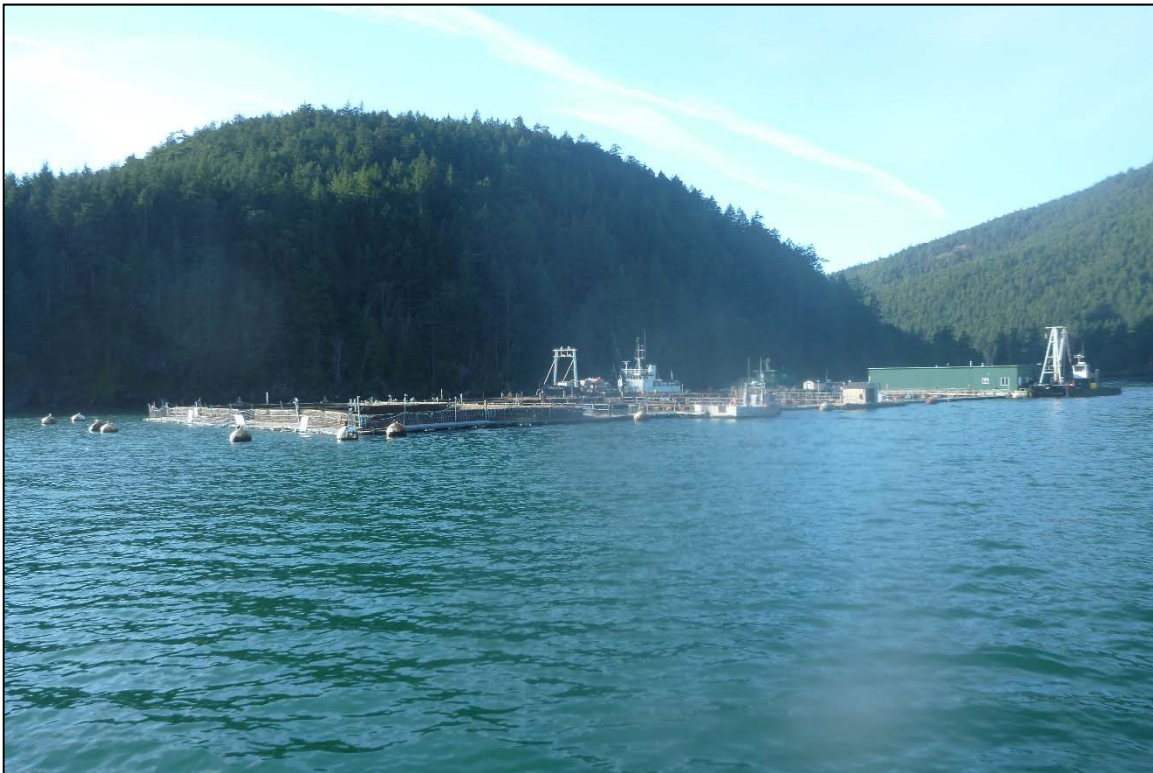
Photograph 4: Overall View of the Site 1 Fish Net Pens System, Looking Southwest.

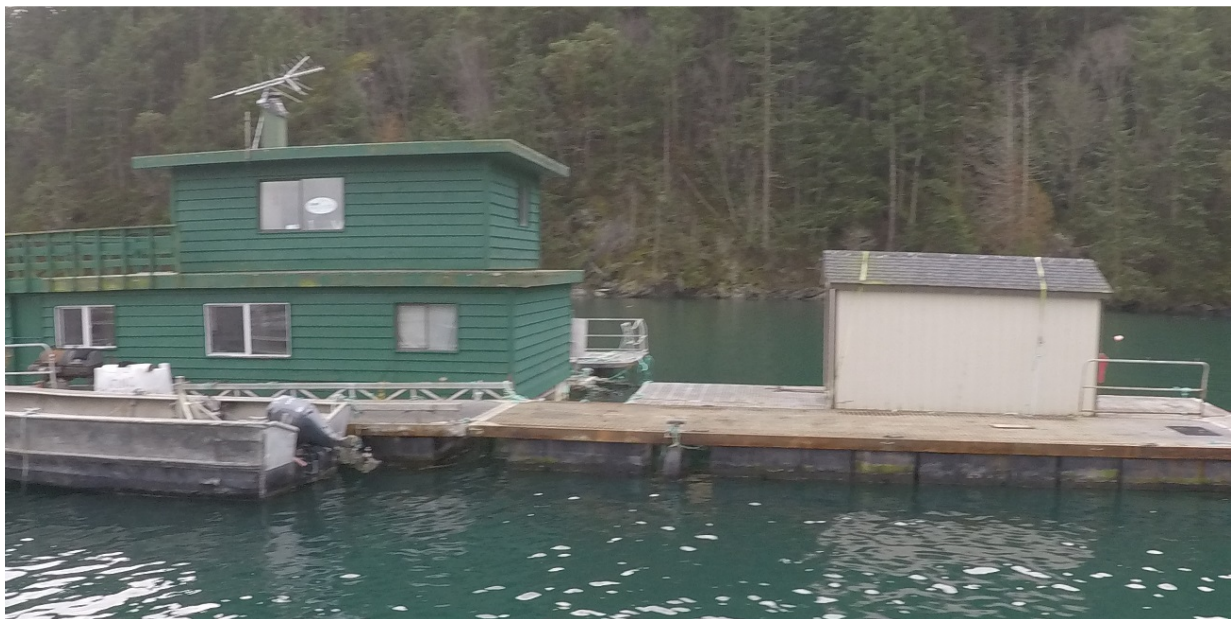
Figure C-4: Cypress Island Net Pen Site 1 – House (Crew Quarters) and Floating Shed

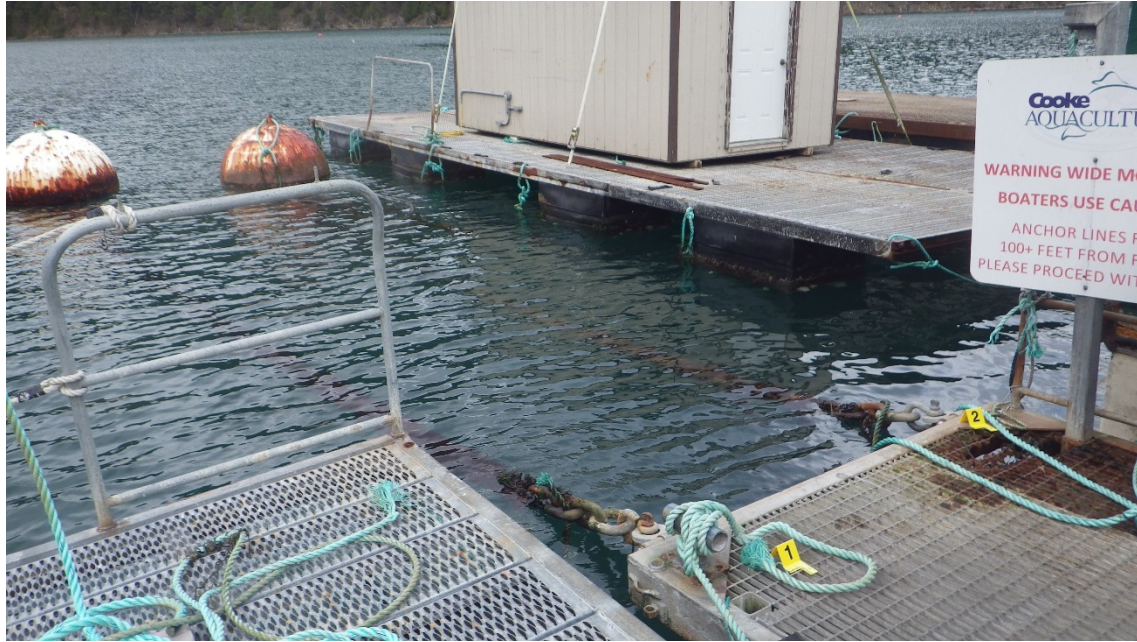
Figure C-5: Cypress Island Net Pen Site 1 – Anchor Lines 1 and 2
