Cypress Island Site 3 Atlantic Salmon Net Pens Engineering Assessment

January 29, 2018

State of Washington
Department of Natural
Resources
1111 Washington Street SE
Olympia Washington 98504

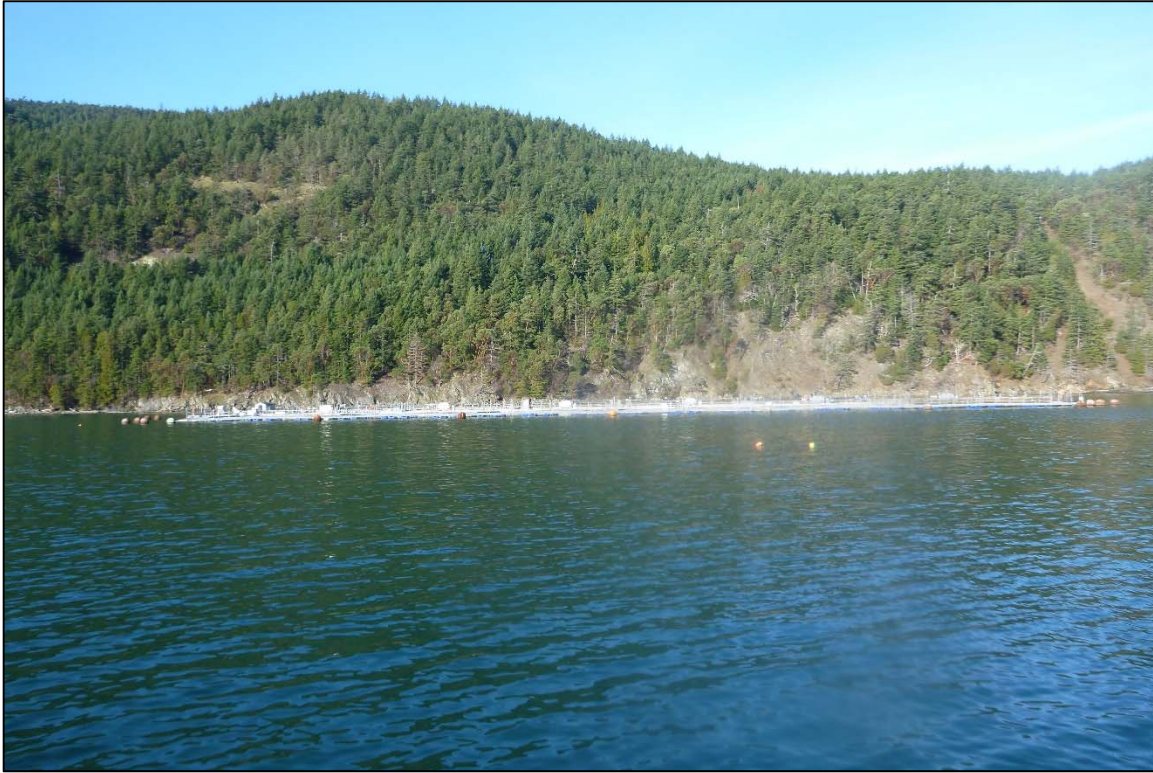
Photograph 1: Overall View of the Site 3 Fish Net Pens System, Looking Northwest.

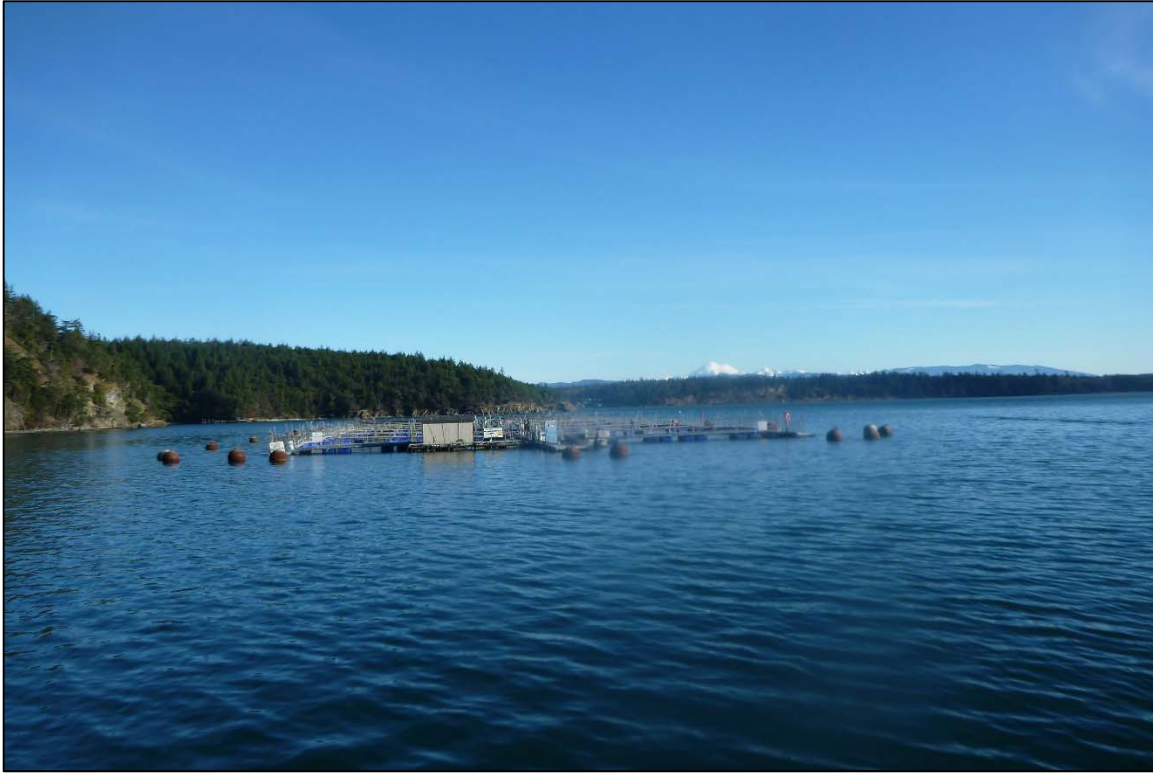
Photograph 3: Overall View of the Site 3 Fish Net Pens System, Looking Northeast.

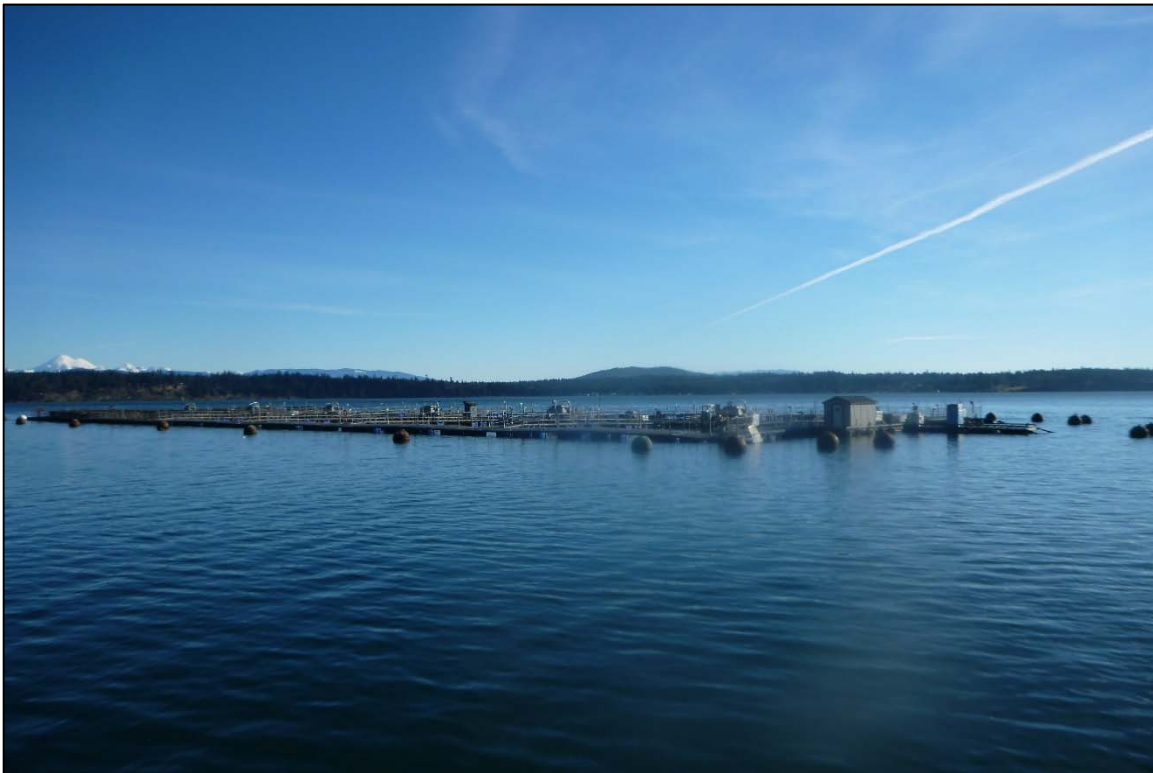
Photograph 4: Overall View of the Site 3 Fish Net Pens System, Looking East.

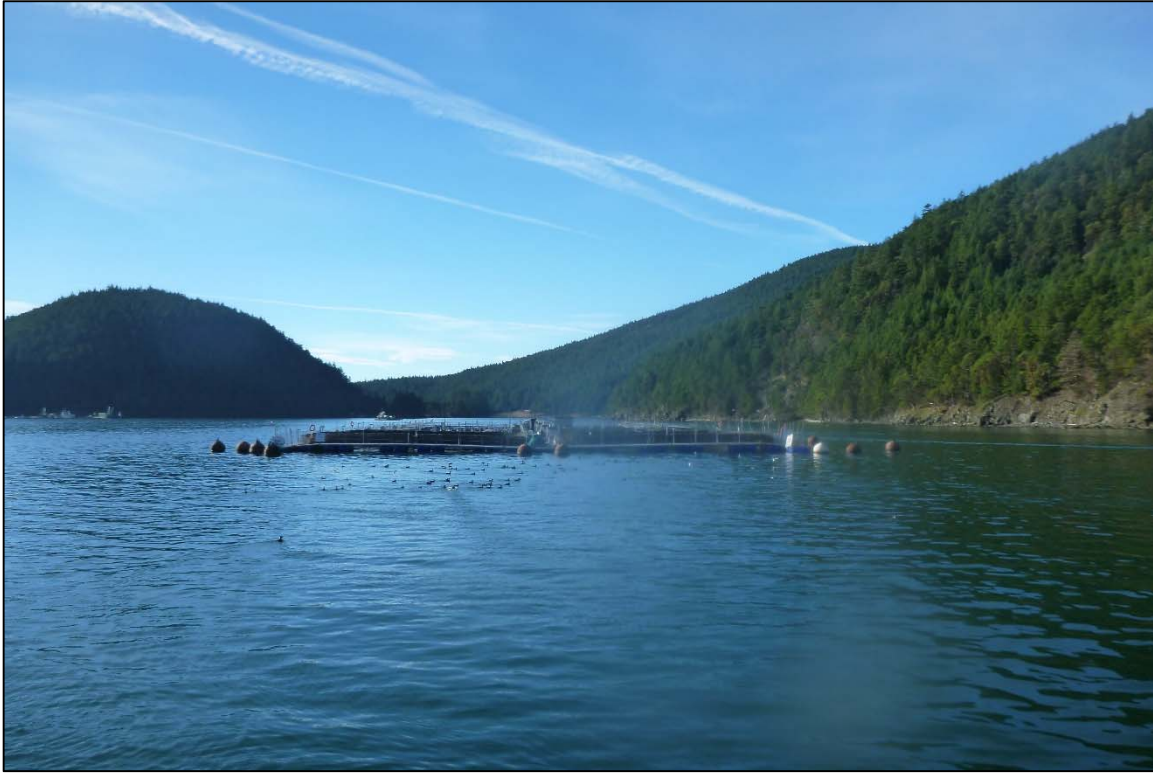
Photograph 5: Overall View of the Site 3 Fish Net Pens System, Looking Southwest.

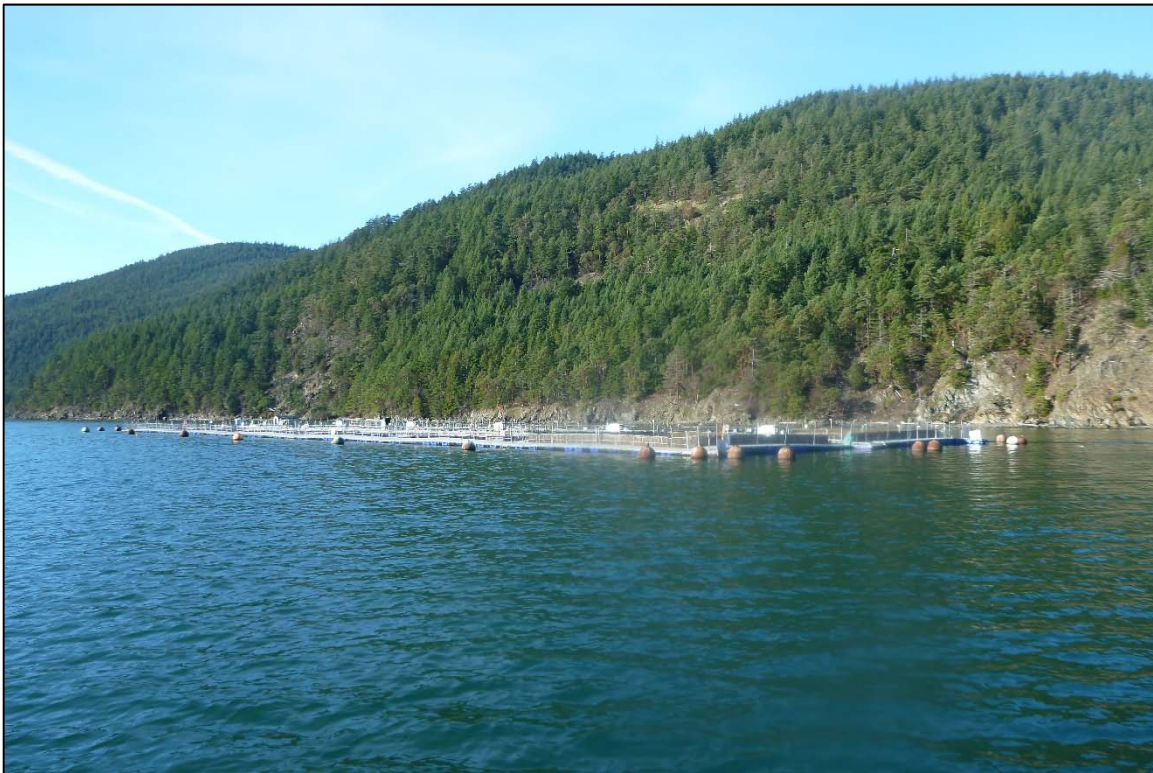
Photograph 6: Overall View of the Site 3 Fish Net Pens System, Looking West.

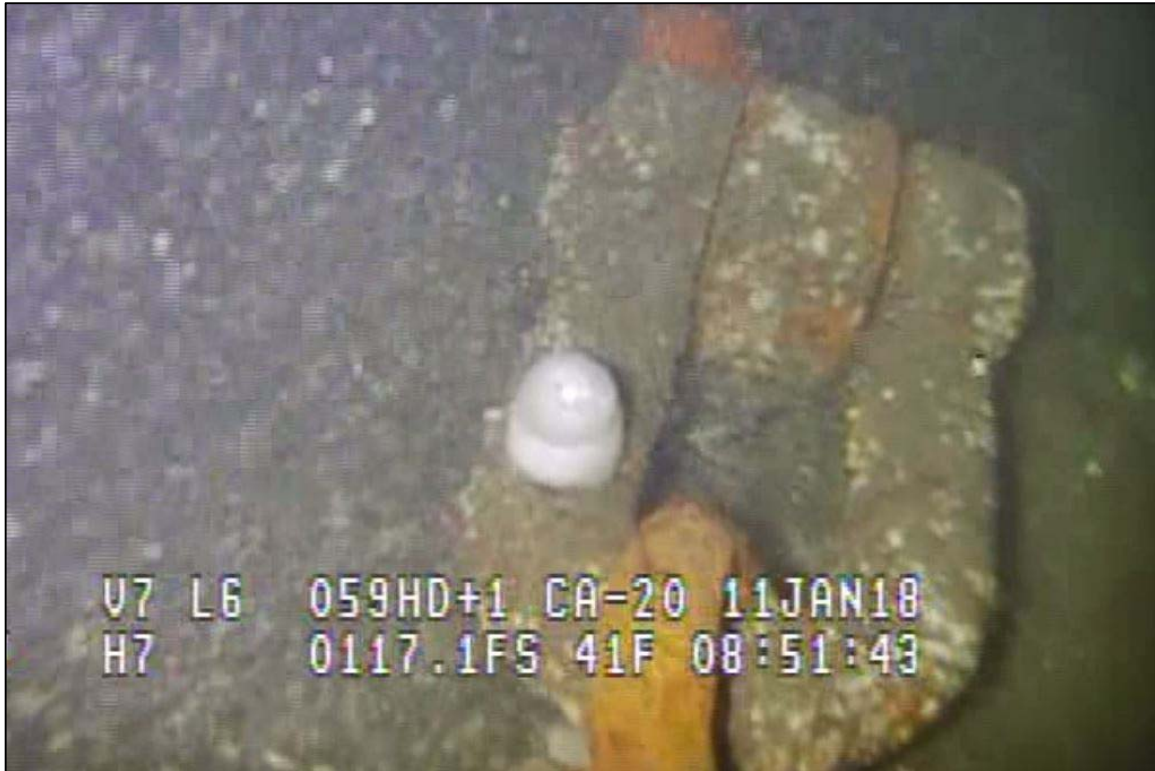
Photograph 17: View of Lower Anchor Chain to Anchor Stem Connection (Shackle) at Site 3 Anchor Line 2, Looking North.
