Port Angeles Primary Atlantic Salmon Net Pens Engineering Assessment

January 29, 2018

Document reference: 391980 | 2 | b

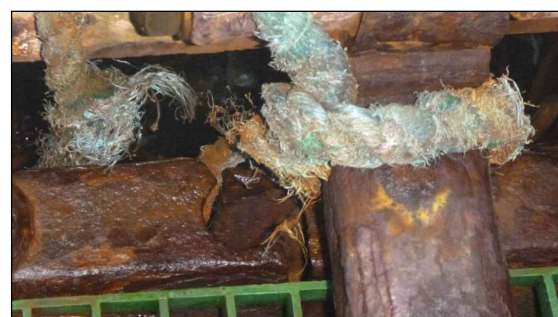
PHOTO 7
TYPICAL CORROSION AND DAMAGE TO PRIMARY FRAME OF BOARDING FLOATS

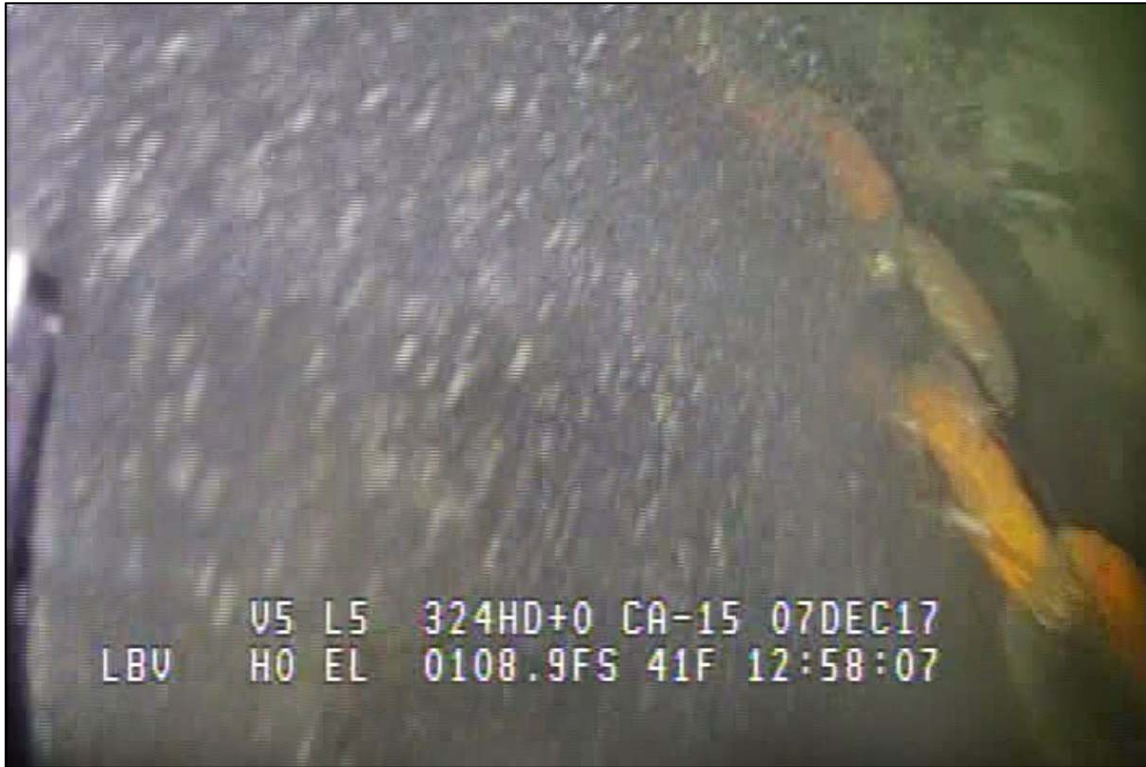
Photograph 64: View of Lower Anchor Chain Condition (Typical) at Primary System Anchor Line 19, Looking West.

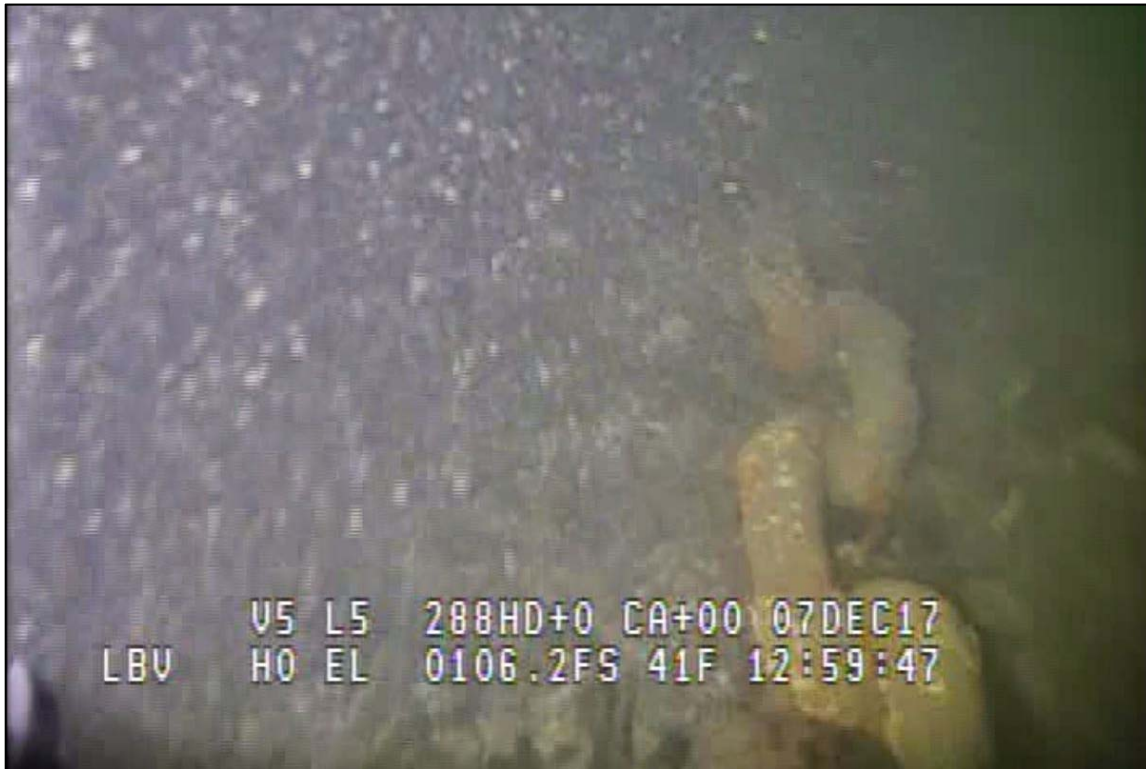
Photograph 65: View of Lower Anchor Chain Embedment in the Channel Bottom at Primary System Anchor Line 19, Looking West.

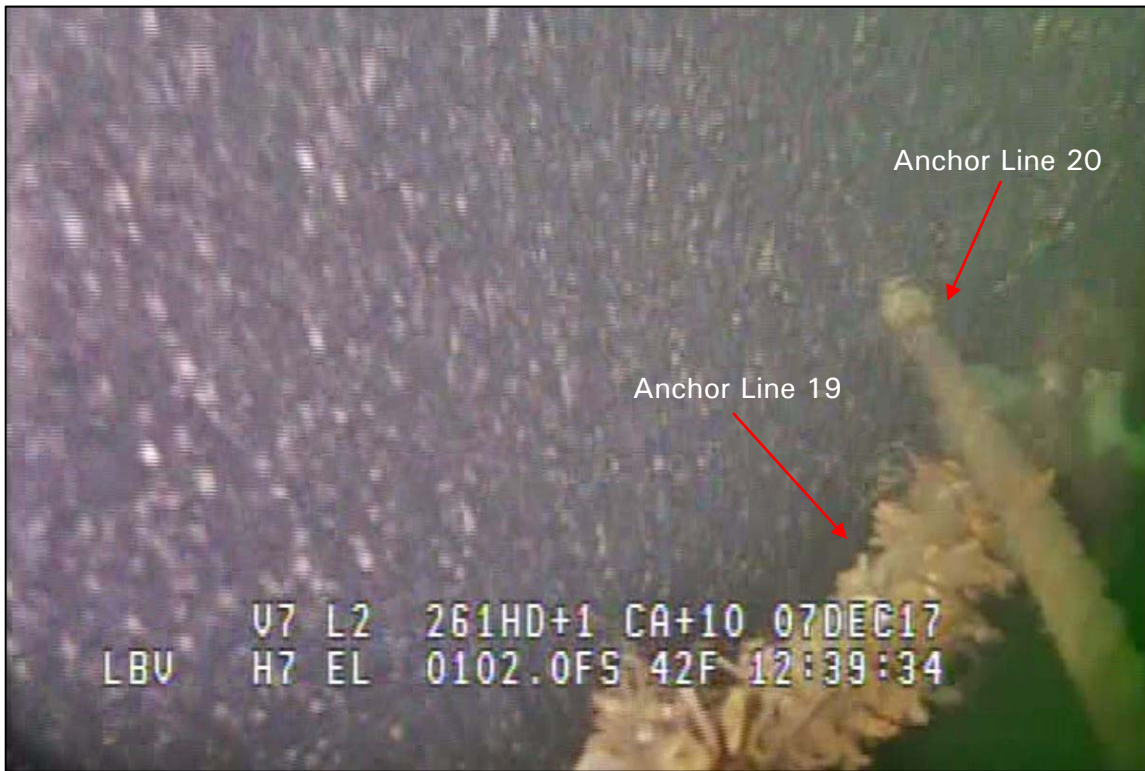
Photograph 68: View of Anchor South Fluke Exposure in the Channel Bottom at Primary System Anchor Line 19, Looking West.

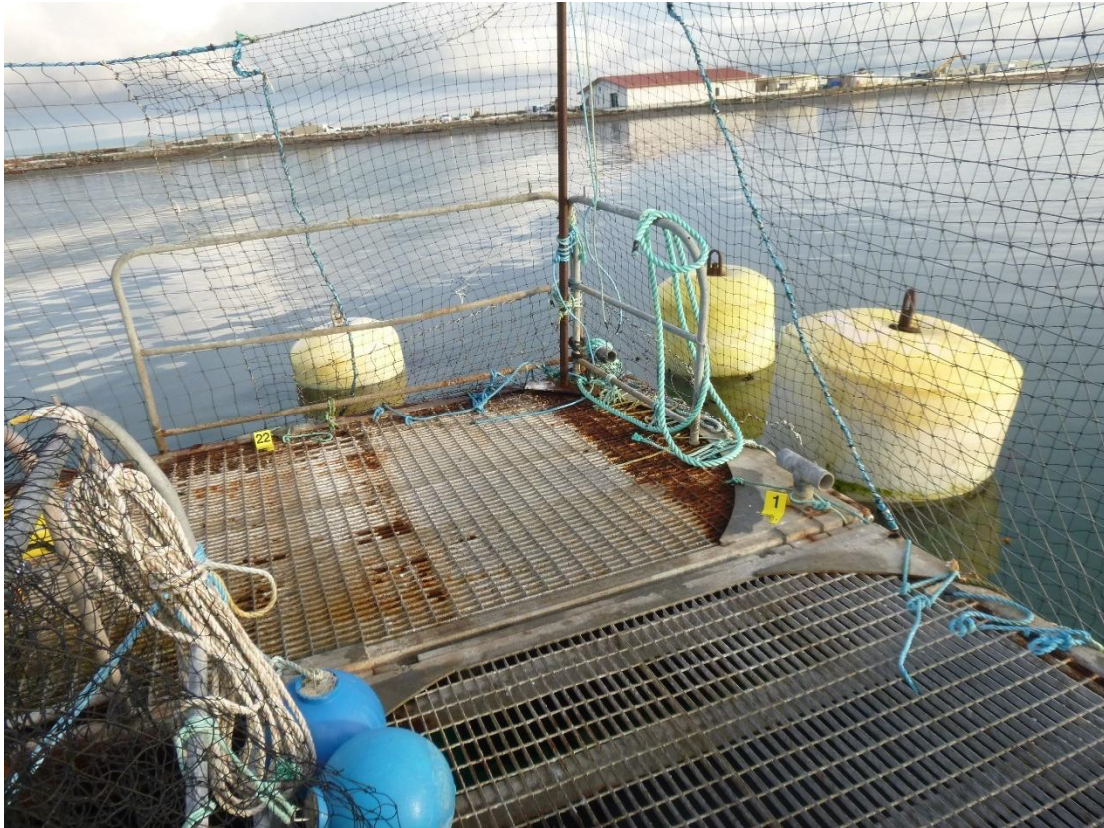
Figure C-2: Port Angeles Net Pens – North East Corner Anchor 1 and 22

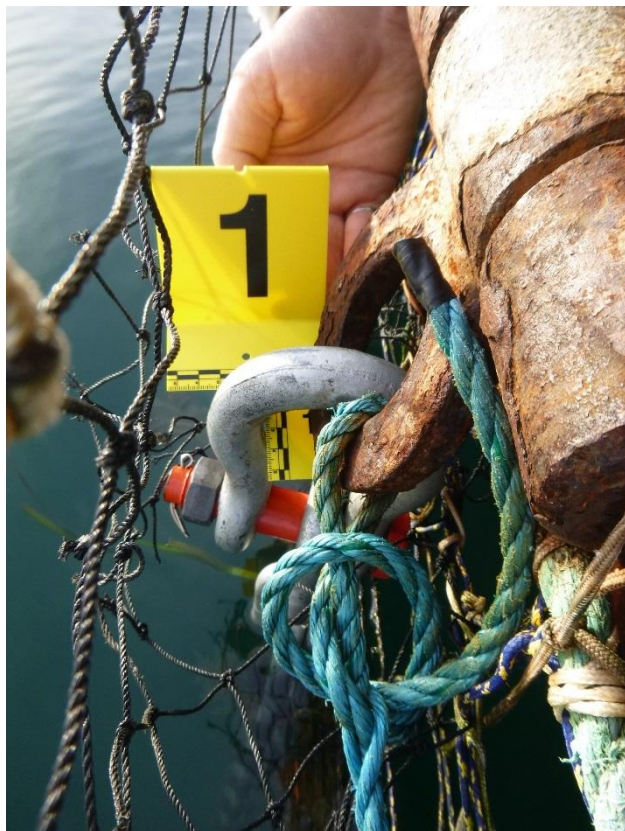
Figure C-3: Anchor 1- Shackle and Padeye

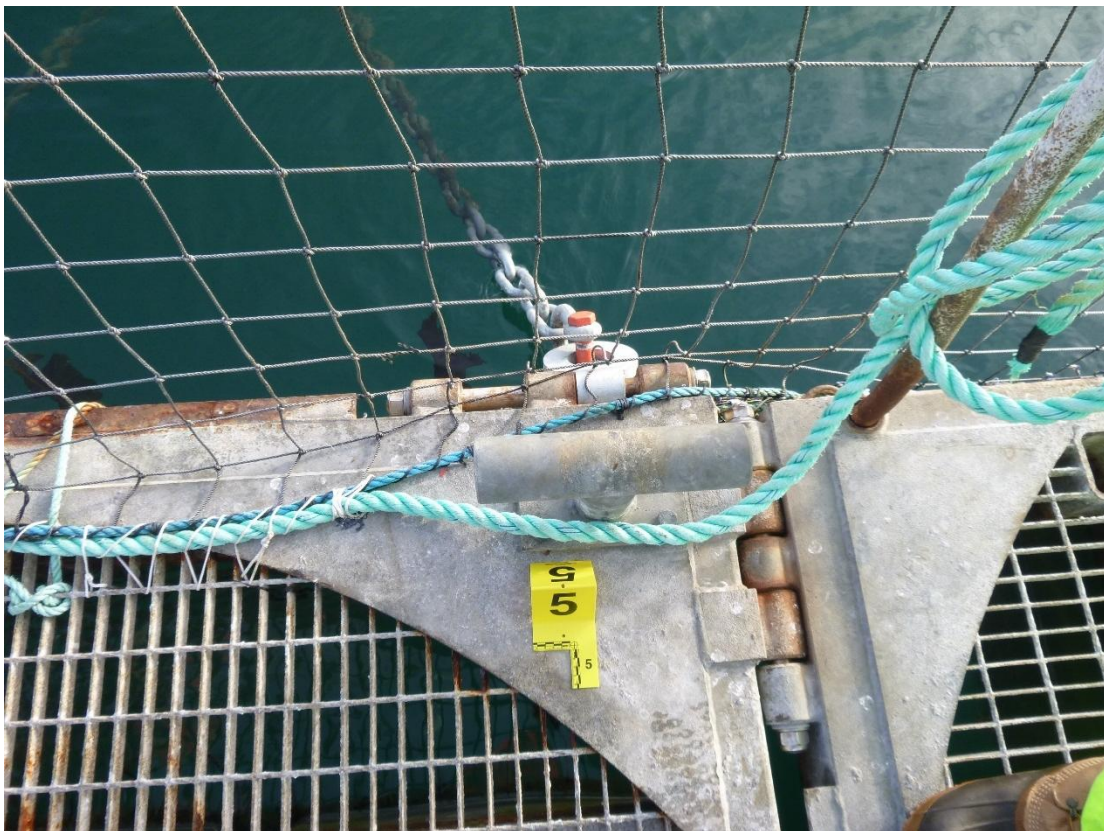
Figure C-15: Anchor 5 New Right Padeye and Shackle

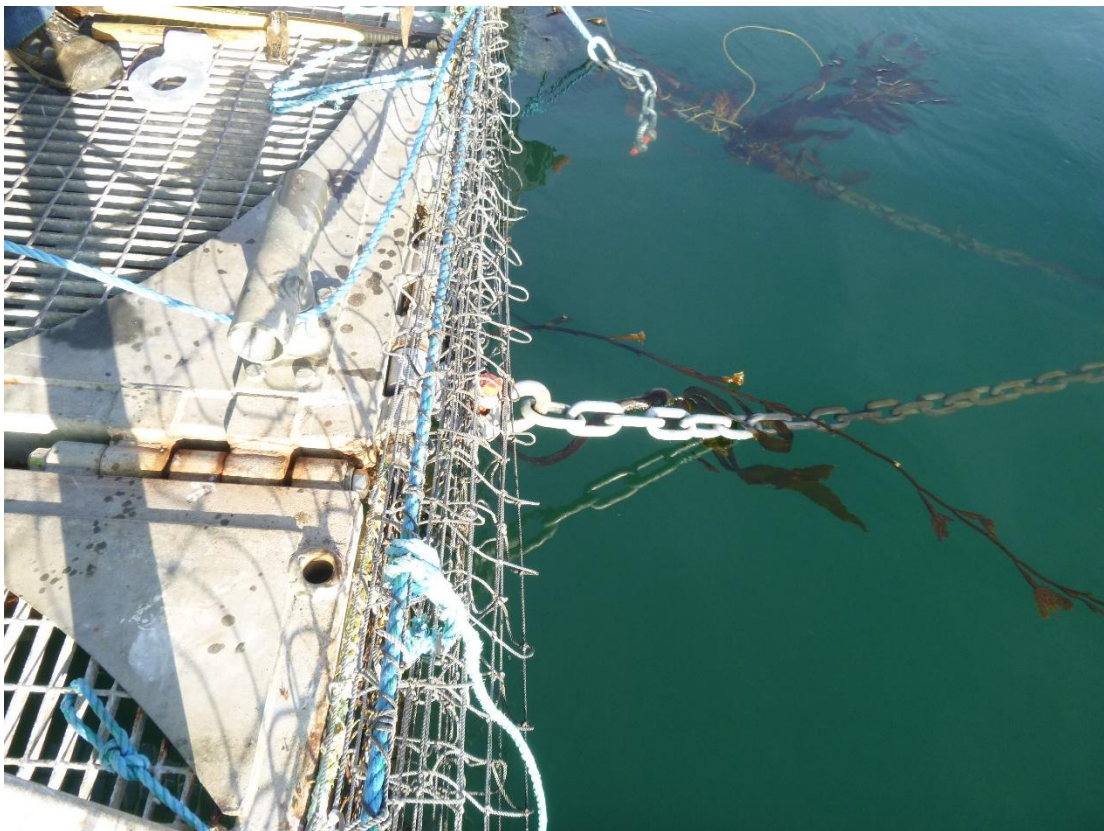
Figure C-25: Anchor 8 Bridle Chain & Shackles

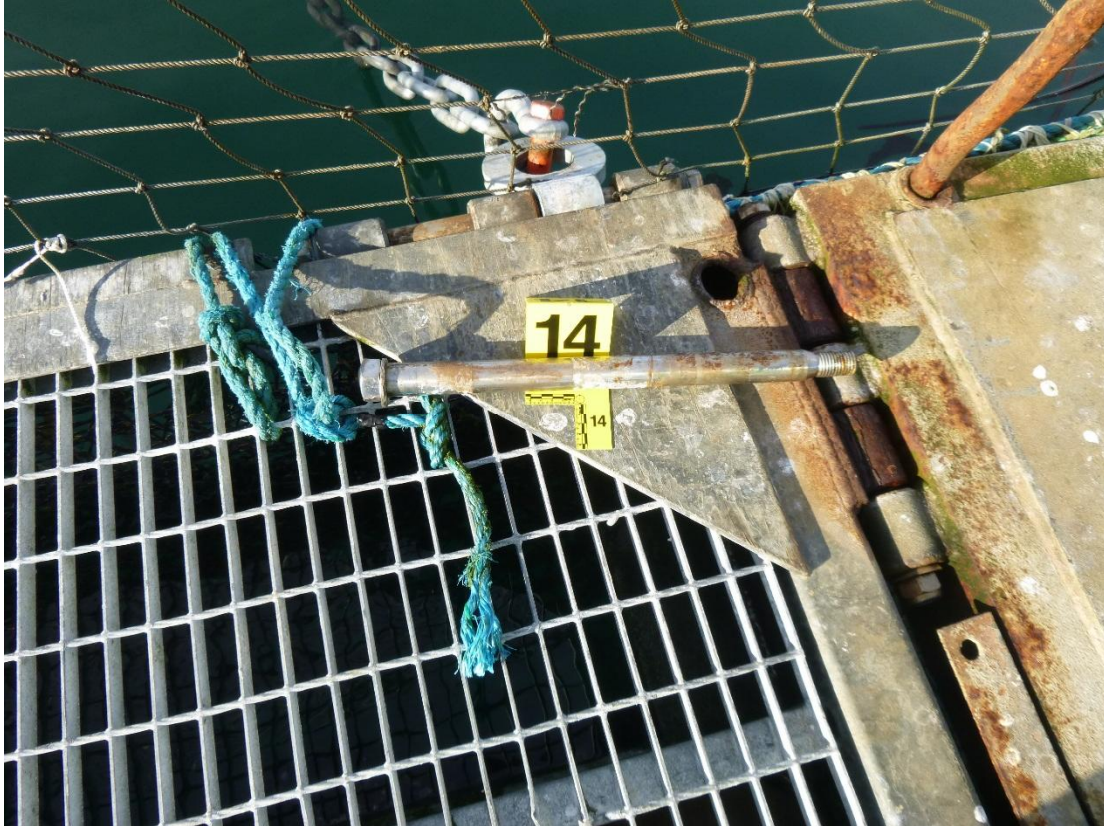
Figure C-44: Anchor 14 Right Shackle, Padeye and Typical S.S. Hinge Pin

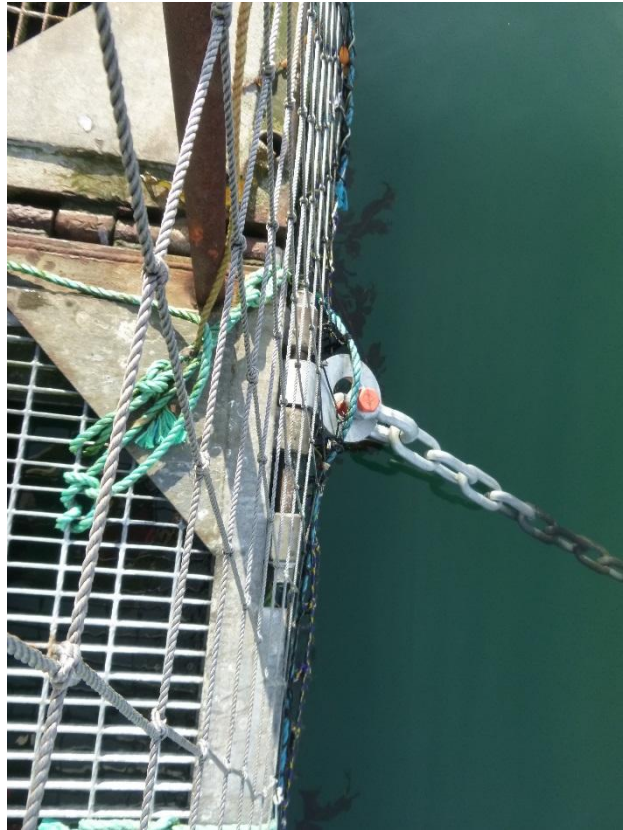
Figure C-46: Anchor 14 Left Shackle and Padeye

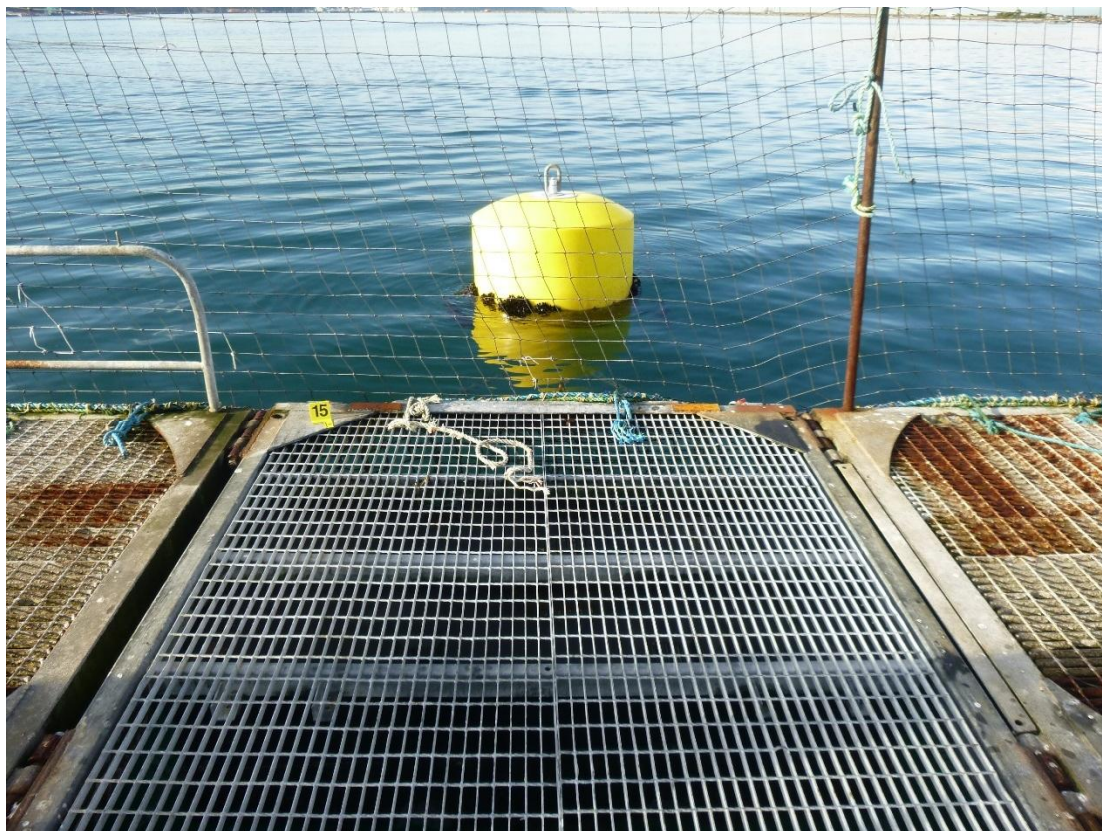
Figure C-47: Anchor 15

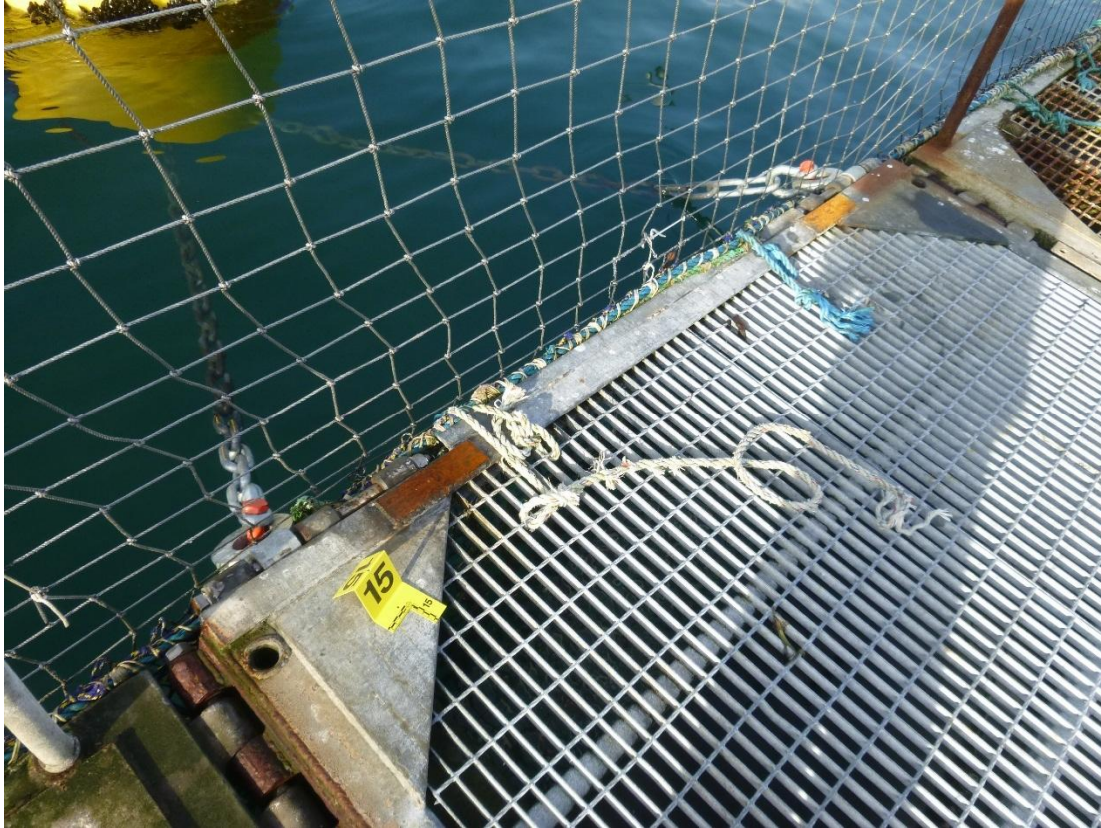
Figure C-48: Anchor 15 Bridle, Shackles and Padeyes

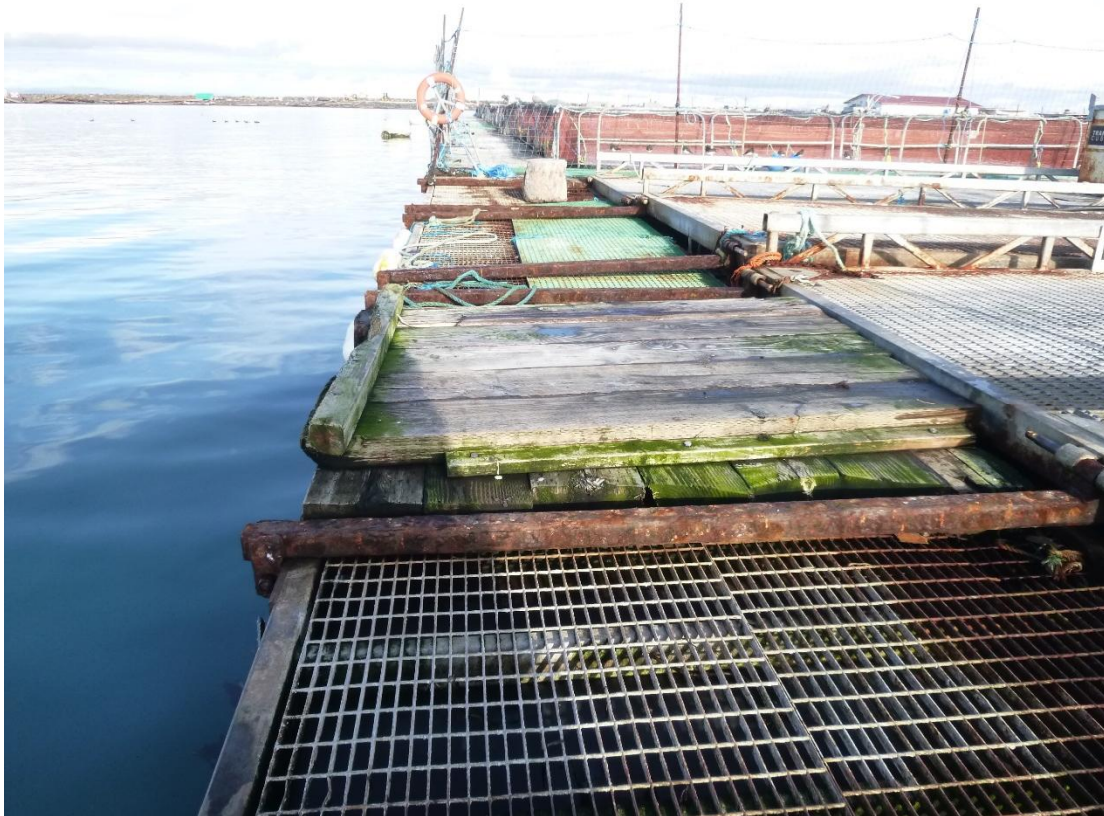
Figure C-52: Floating Dock Boarding Area Between 6 and 8 Pen Sections on West Side

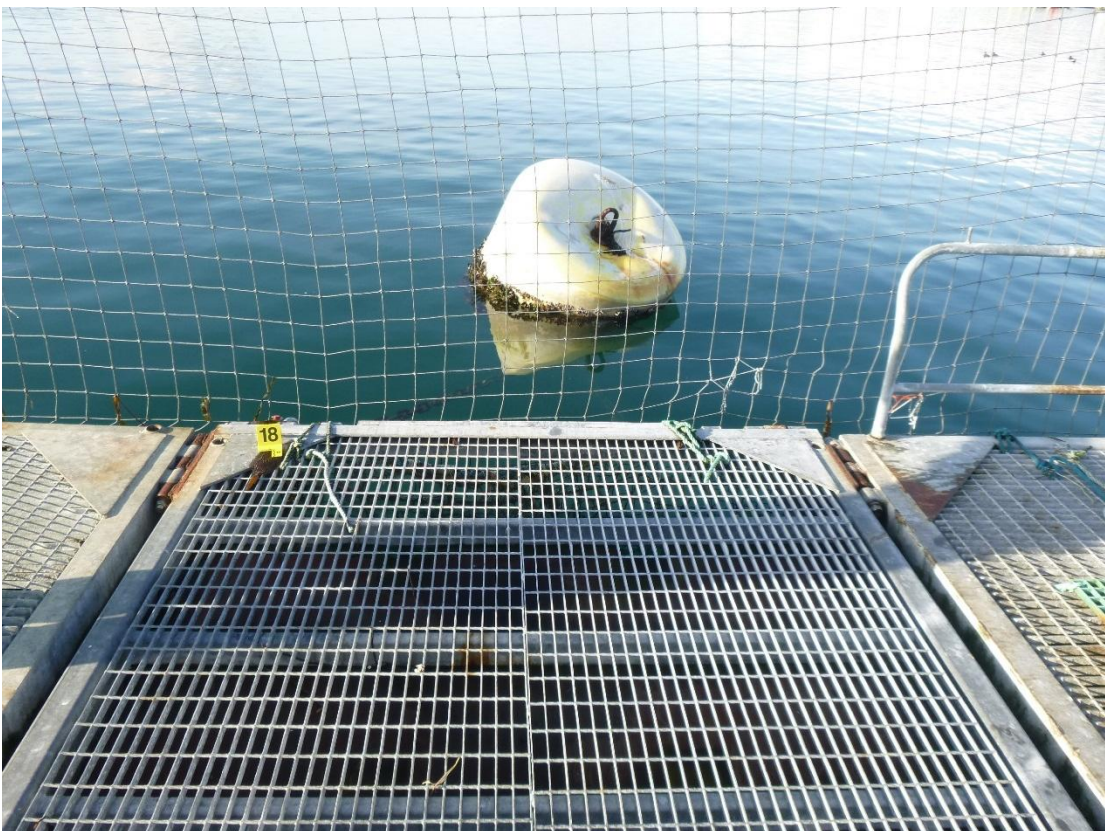
Figure C-59: Anchor 18

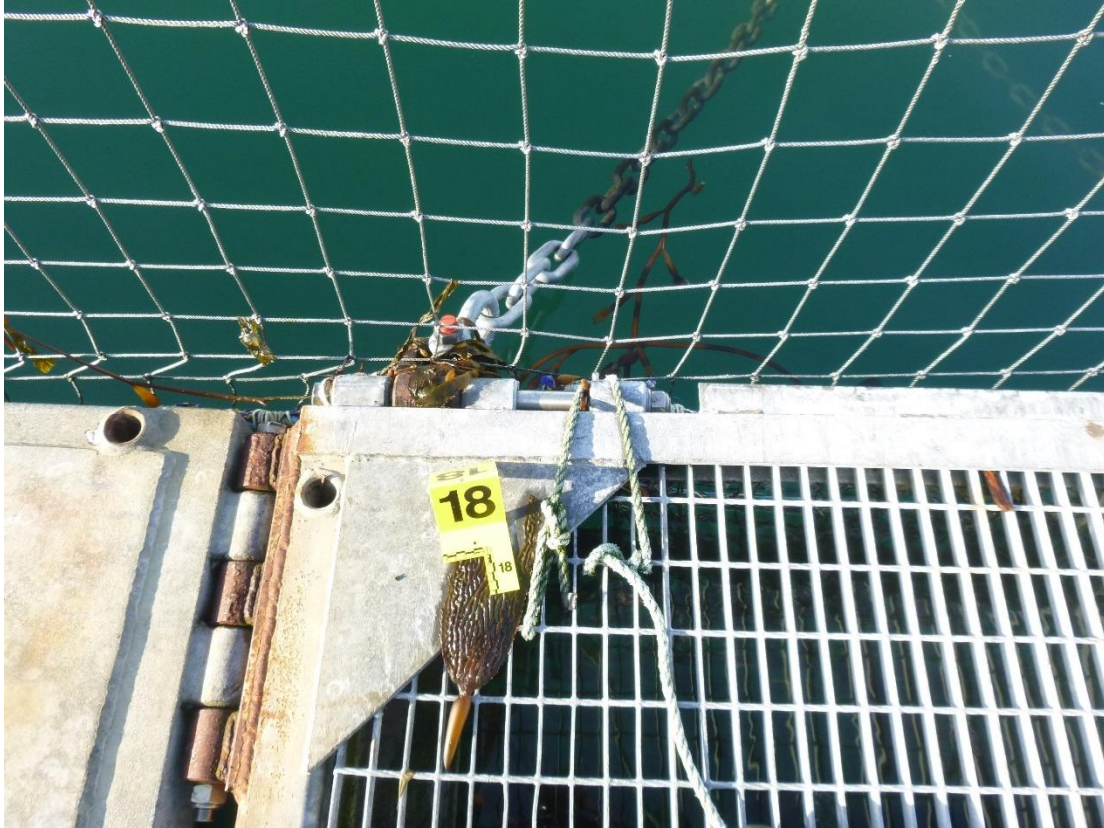
Figure C-60: Anchor 18 Left Padeye, Shackle and Chain

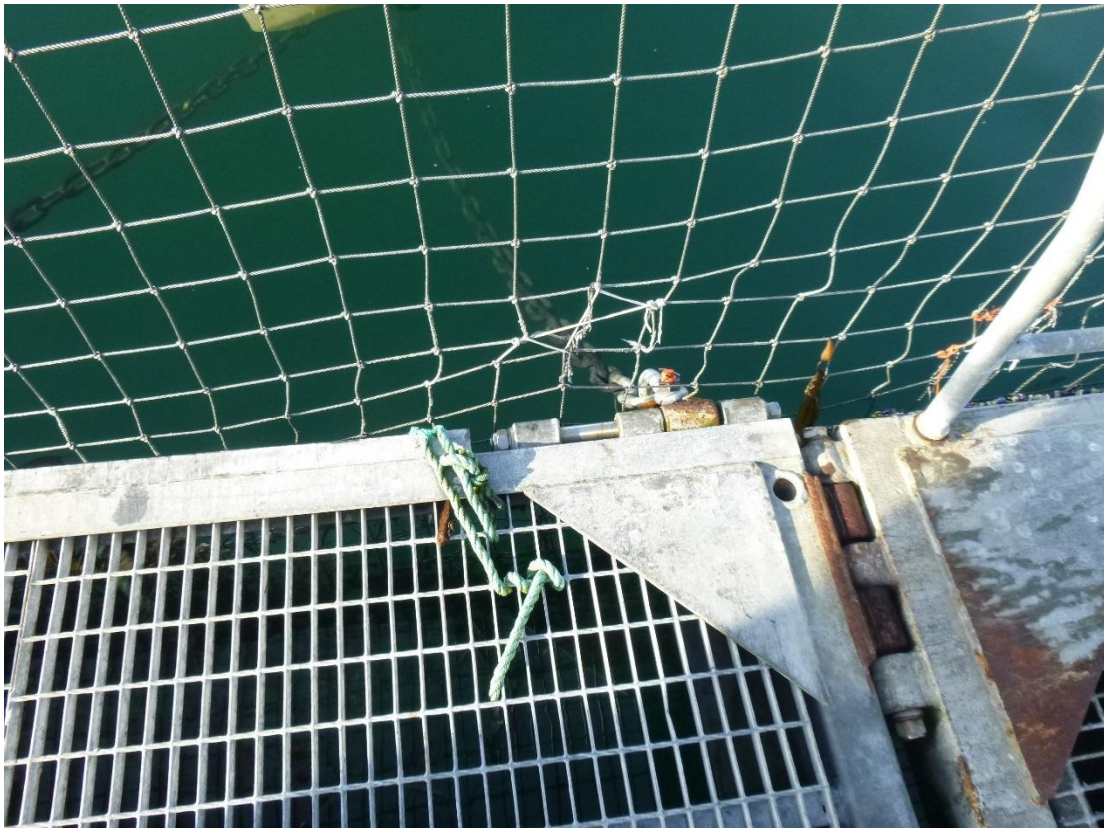
Figure C-61: Anchor 18 Right Padeye Shackle and Chain

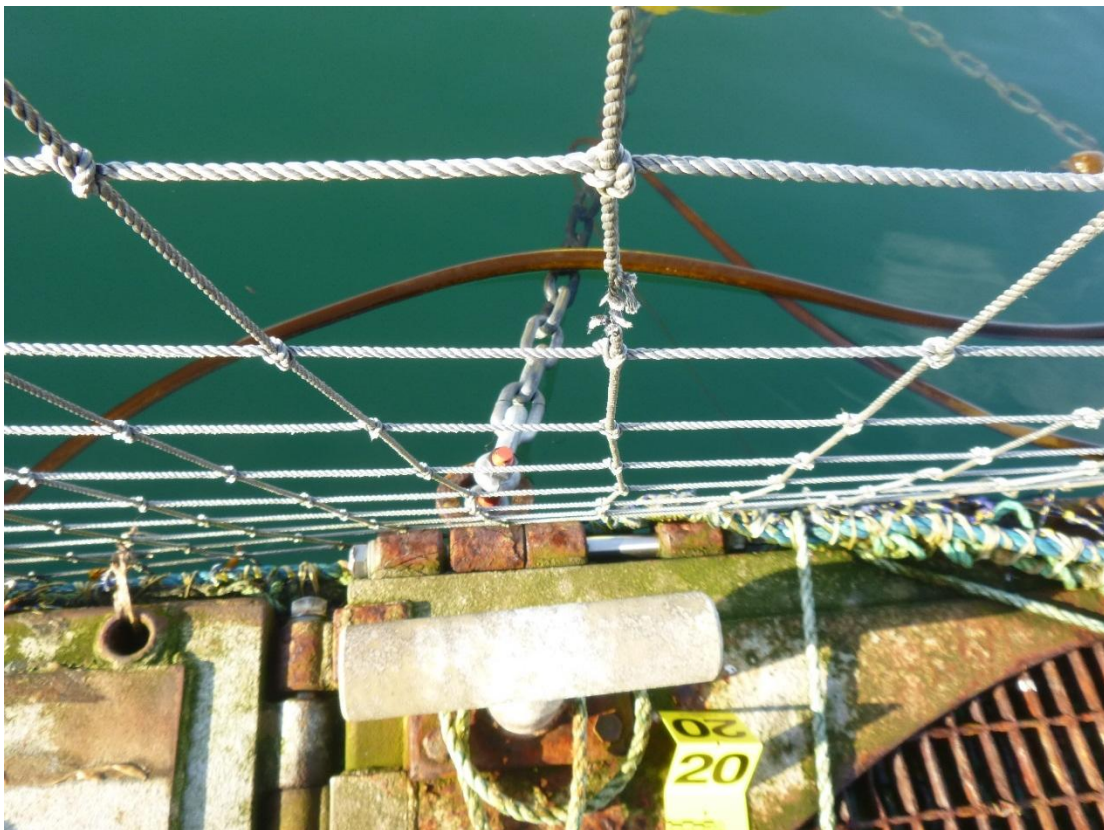
Figure C-67: Anchor 20 Left Padeye, Shackle and Chain

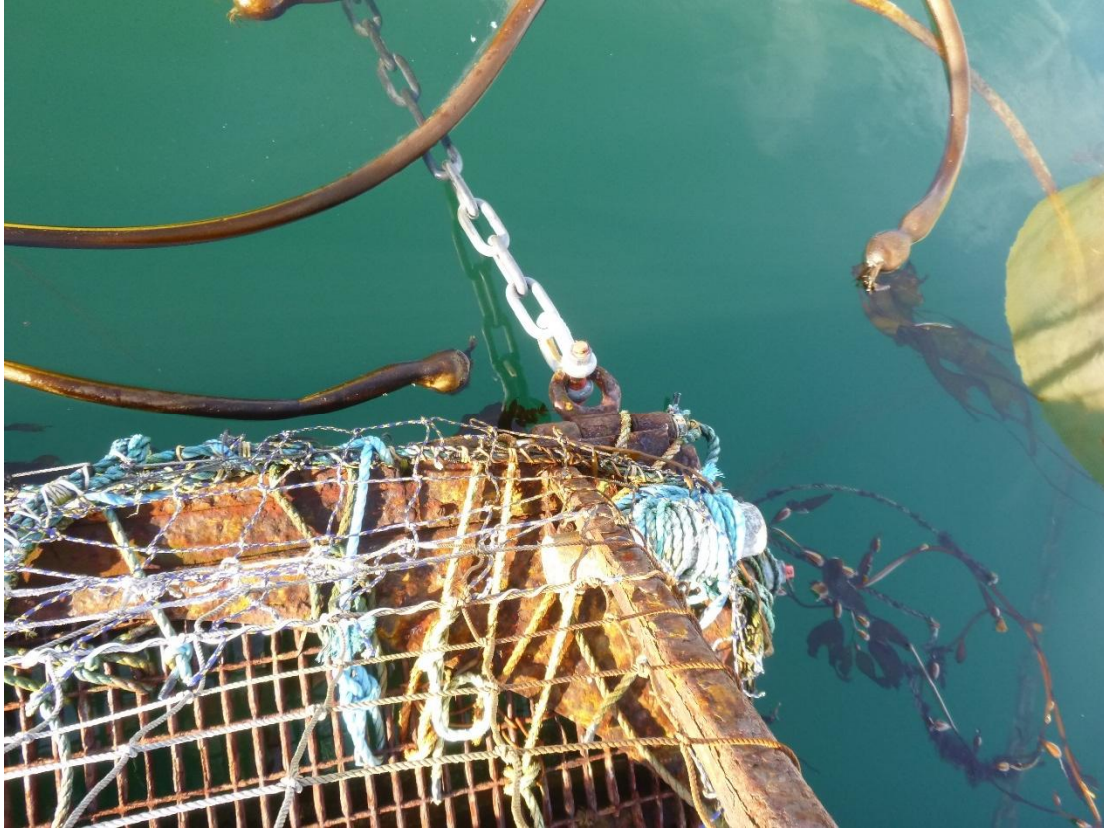
Figure C-68: Anchor 20 Right Padeye, Shackle and Chain

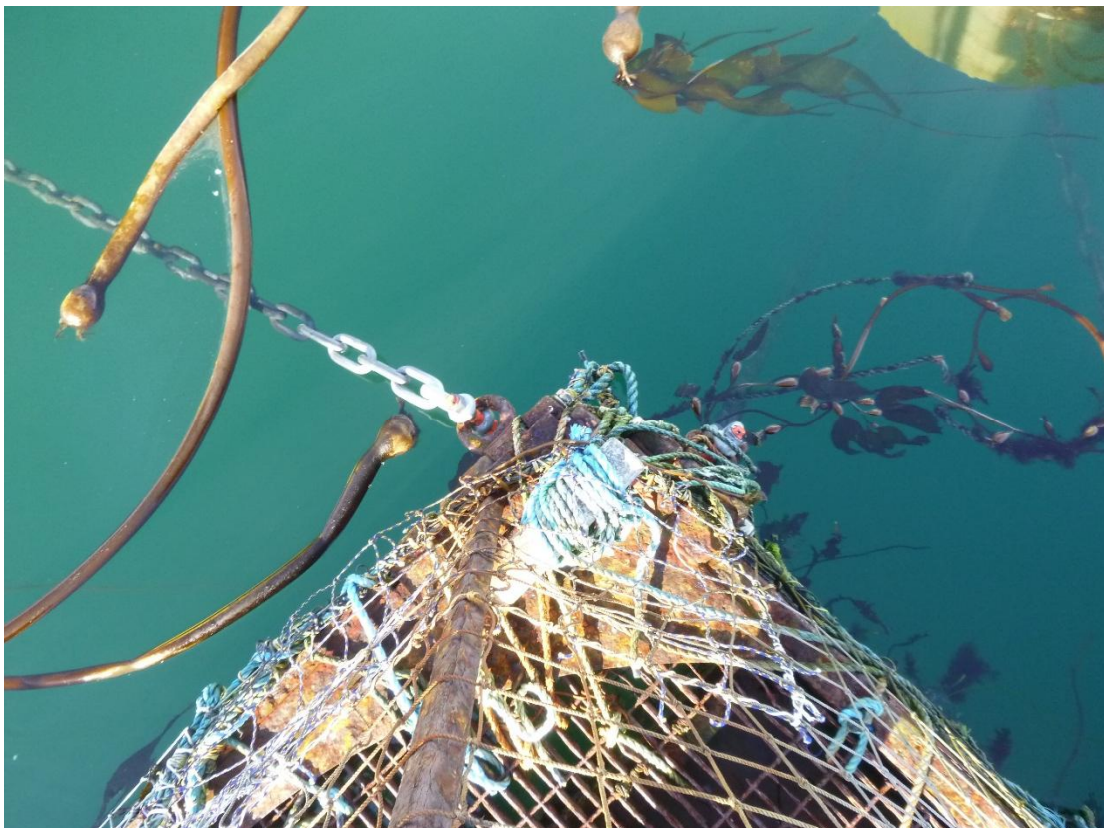
Figure C-71: Anchor 21 Left Padeye, Shackle and Chain (Single Hinge Setup)

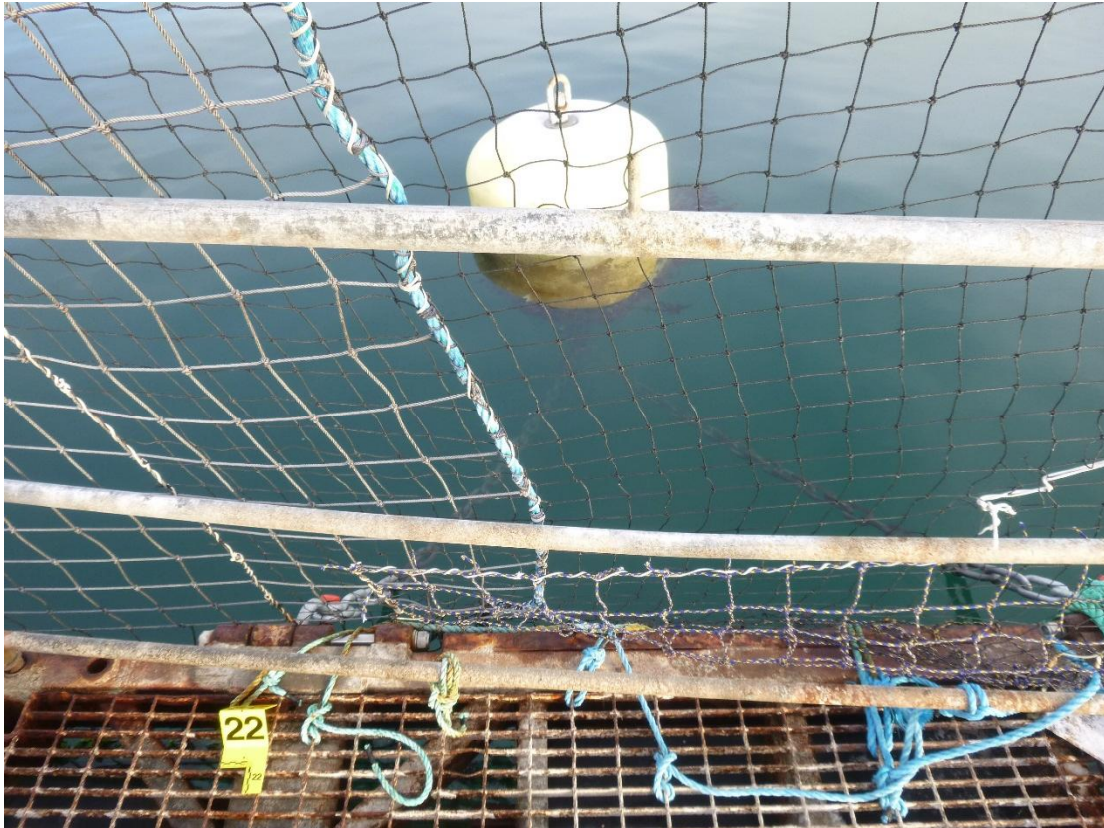
Figure C-72: Anchor 22

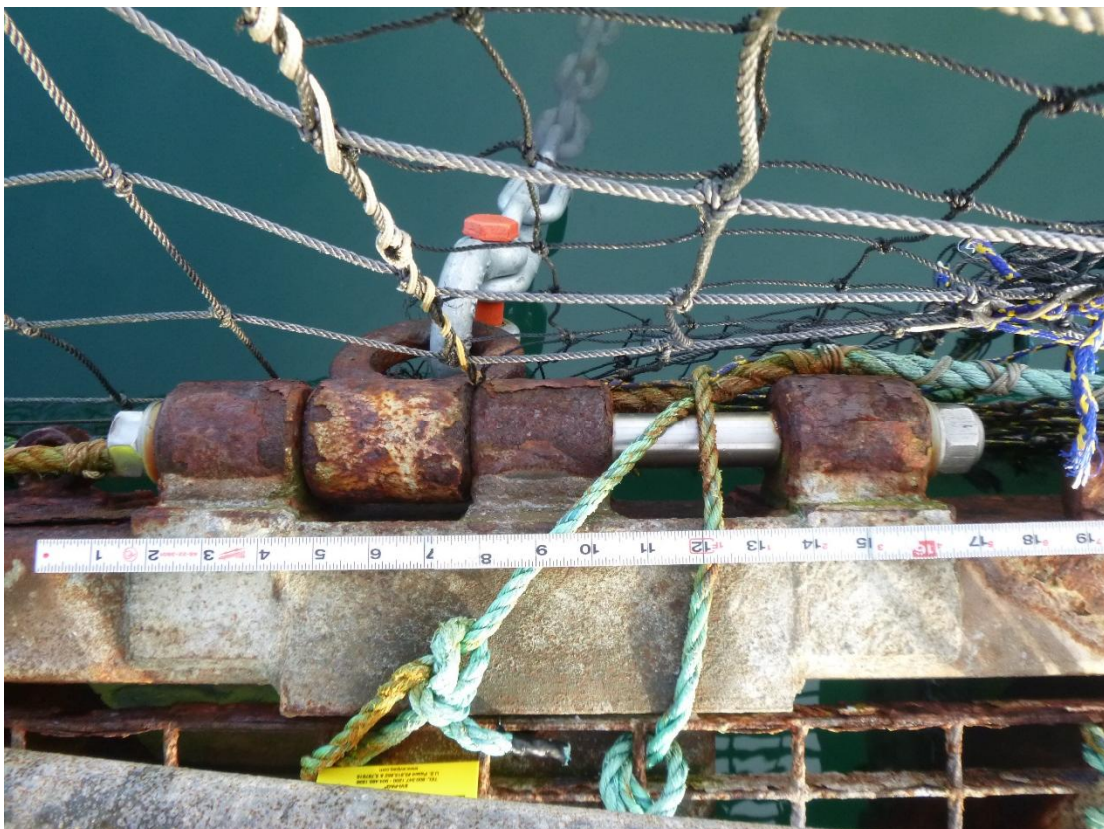
Figure C-73: Anchor 22 Left Padeye, Shackle and Chain

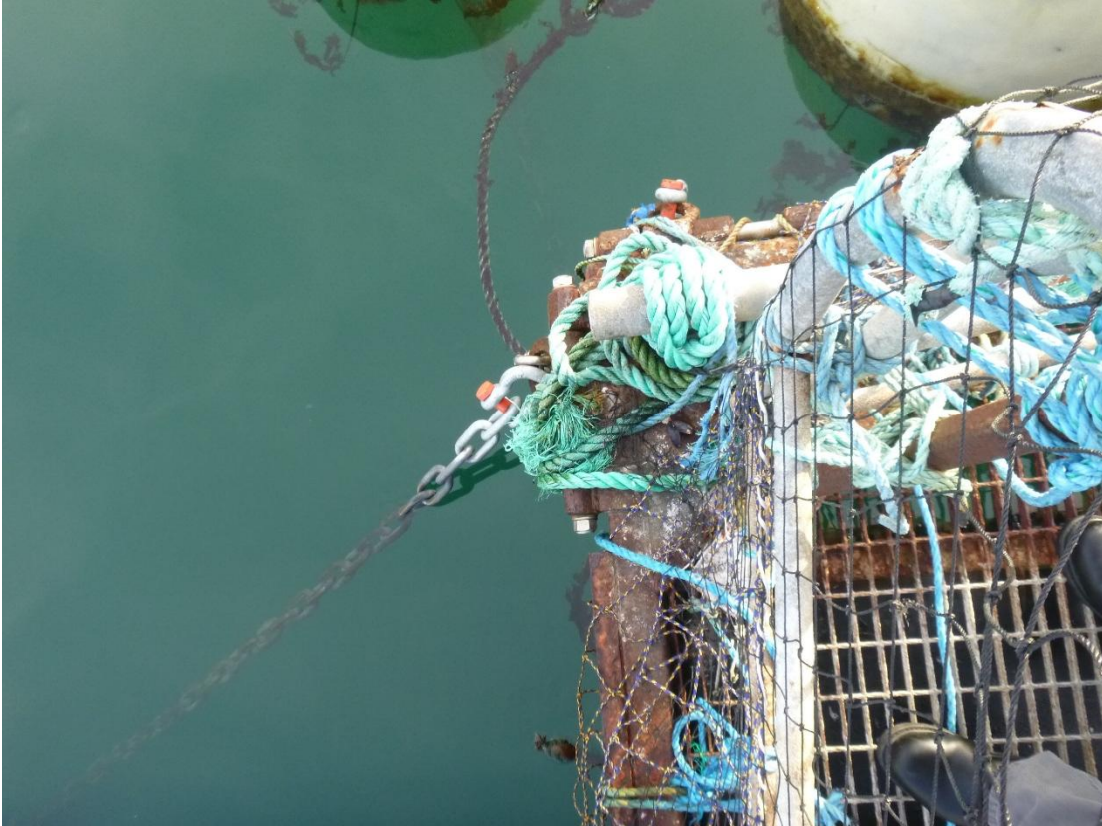
Figure C-74: Anchor 22 Right Padeye, Shackle and Chain

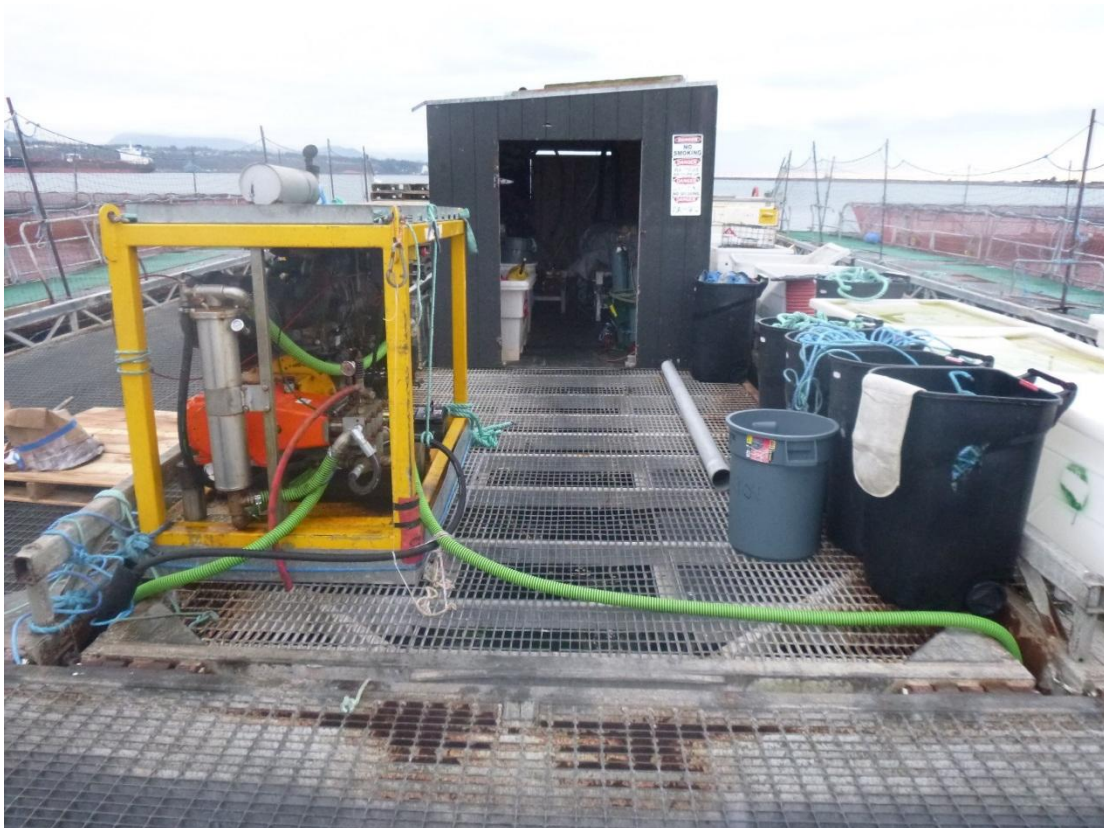
Figure C-81: Boarding Area Between 6 and 8 Pen Sections – Middle Dock Looking West

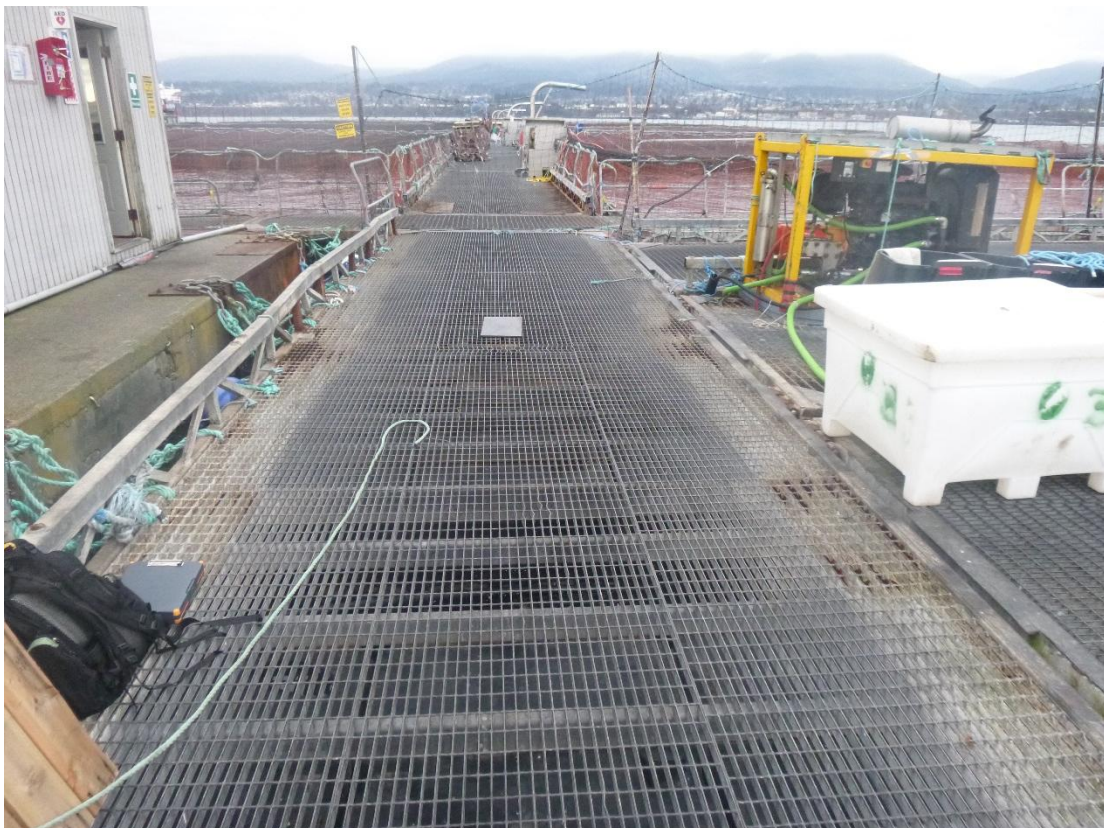
Figure C-83: Main Dock Between Boarding Area and Barge – Looking South
