# **Rich Passage Orchard Rocks Atlantic Salmon Net Pens Engineering Assessment**

January 29, 2018

Mott MacDonald  
110 James Street  
Suite 101  
Edmonds WA 98020  
United States of America

State of Washington  
Department of Natural  
Resources  
1111 Washington Street SE  
Olympia Washington 98504

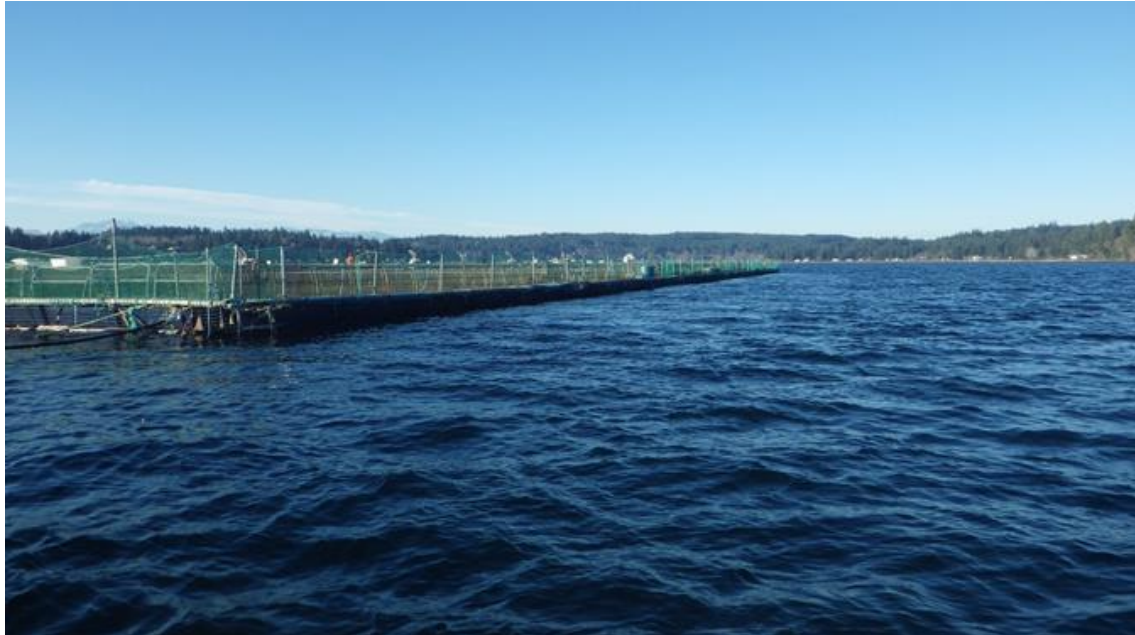
**Figure 8: Orchard Rocks Net Pens – View from East**

During the site visit observations were made and photos were taken. On both days the weather was cold at roughly 40°F at noon with winds light and variable, and the sea calm. Wake waves from ferries up to 1 feet high were observed passing through the structure with no observable motion of the net pen while the waves propagated through the facility. The predicted tide elevations on the first day are below in **Table 3**. Mean Higher High Water (MHHW) is elevation +11.5 feet, MLLW. The mean tide range is 6.7 feet. The predicted currents at the east end of Rich Passage are in **Table 4**. The maximum predicted current speed during the site visit was approximately 0.7 knots. However, the measured current near the south-east corner of the Fort Ward net pen was approximately 1.1 knots at 2017-12-11 15:38h, determined by measuring the time and distance of a floating object relative to points on the net pen. This is approximately equal to the predicted current speed at that time.

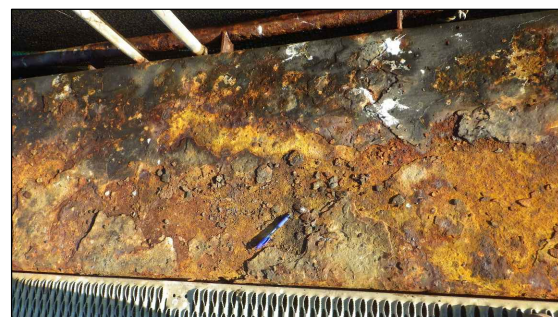
**PHOTO 7**  
 MAJOR CORROSION ON WALKWAY

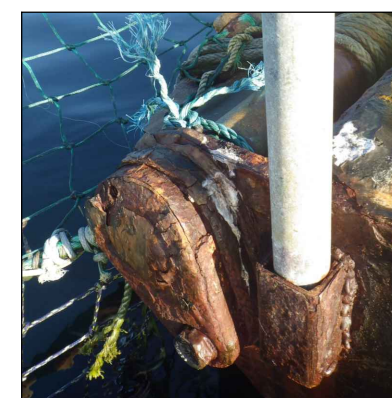
**PHOTO 9**  
 SEIZED HINGE AT ANCHOR 13
